# Sonoma County DRAFT Villa Grande Drainage Study September 2022

Job # SONO.01

PREPARED FOR: County of Sonoma 2300 County Center Dr Santa Rosa, CA 95403 Project #E20010

PREPARED BY: Schaaf & Wheeler 870 Market Street, Suite 1278 San Francisco, CA 94102

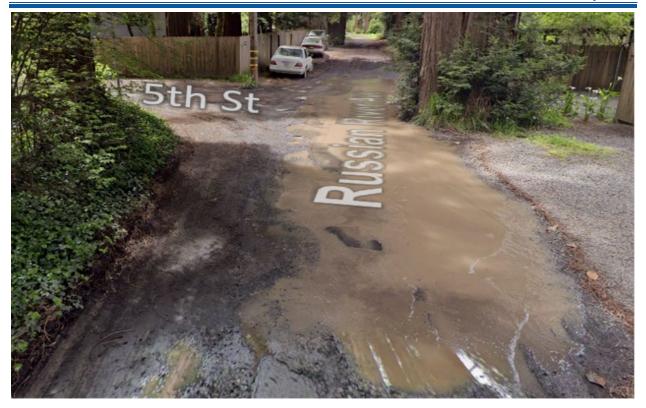
Figure 5-3: Ponded Water at Russian River Ave & 5th Street

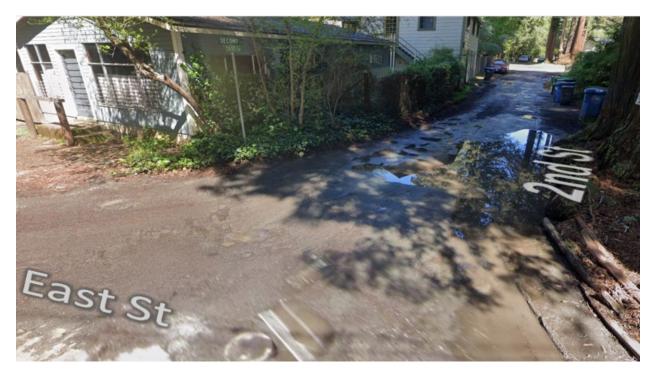
Figure 5-4: Ponded Water at East Street and 2<sup>nd</sup> Street

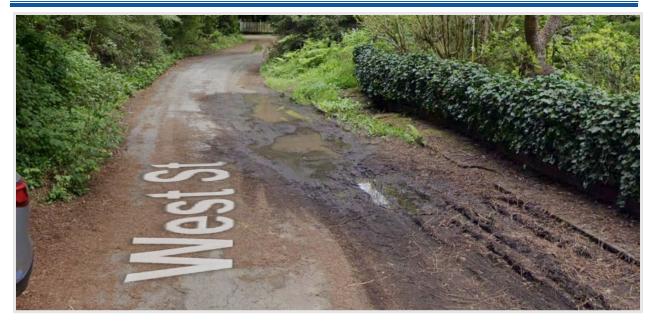
Figure 5-5: Ponded Water and Sediment Buildup on West Street (Between Post Office and East St)

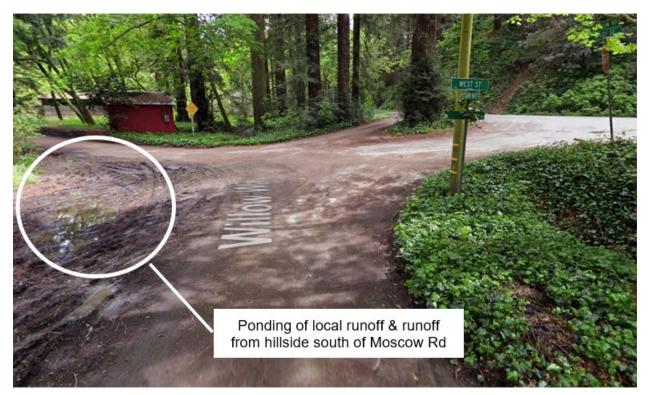
The County identified another location where an additional inlet would be beneficial, on West Street near Willow Road. This is where runoff from Moscow Road tends to run down West Street and pond before entering the ditch system. This is shown in Figure 5-6.

Figure 5-6: Low Point at Willow Road where Runoff from Moscow Road Accumulates

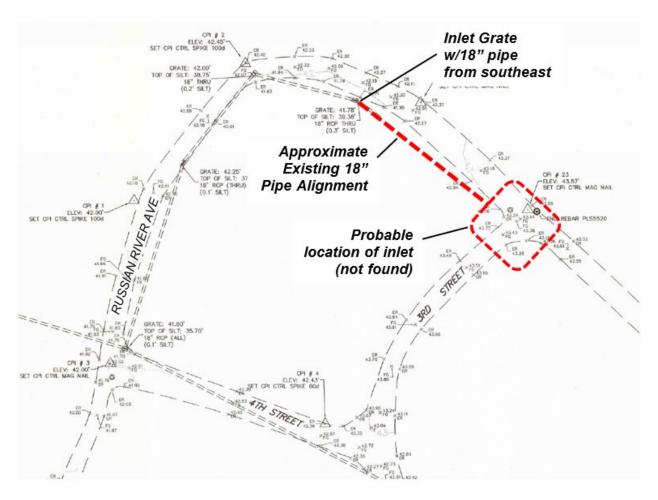
Figure 5-17: Surveyed System Around 3<sup>rd</sup> Street Annotated with Probable Missing Inlet Location.

Attempts to inspect this system and locate the inlet were not successful, as the grates appear to be rusted in place. It's recommended that the catch basins along Russian River Ave be repaired so that grates can be removed, then CCTV be performed on the system. If an inlet can be located, a smaller project should be undertaken that restores it or relocates to a position where it might be more effective at capturing local runoff and conveying it to the 4<sup>th</sup> Street outfall in the existing pipe system, which has adequate capacity available.

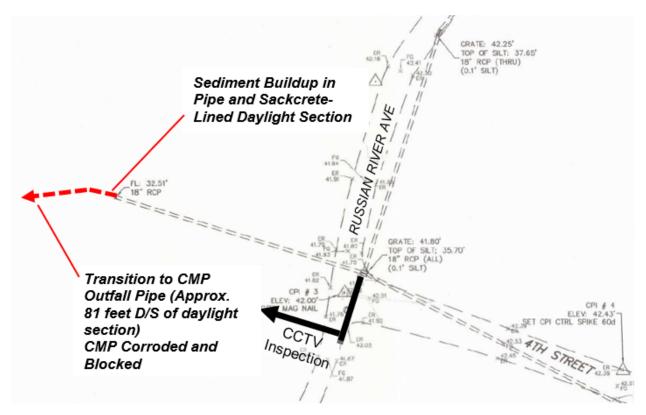
Figure 5-25: 4<sup>th</sup> Street Outfall System

The 4<sup>th</sup> Street system was inspected west of Russian River Ave (Figure 5-25). The 24-inch RCP pipe appears to be in good condition but requires some removal of built-up sediment and debris in order to maintain its capacity (Figure 5-26). Downstream, however, the pipe transitions to a 32-inch CMP with a corroded bottom (Figure 5-27). It's not likely that this will cause flooding in its current condition, as there is a significant drop in invert elevation to the outfall. However, this should be monitored closely for further failure and prioritized for replacement.

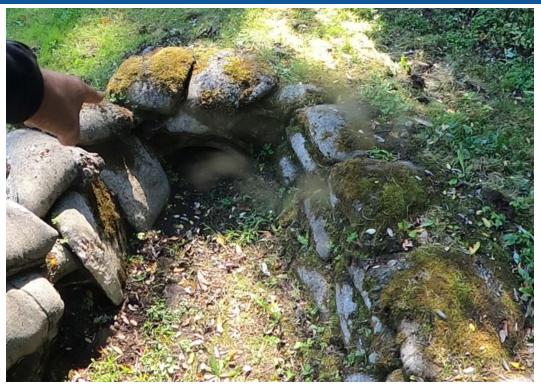
Figure 5-26: 4th Street Outfall Daylight Section Sediment Buildup

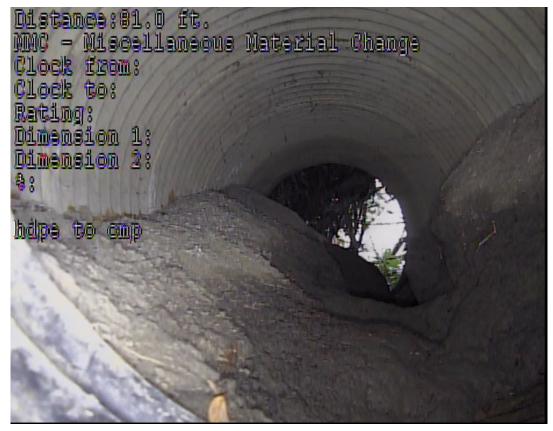
Figure 5-27: Corroded CMP and Outfall Blockage (4th Street Outfall)

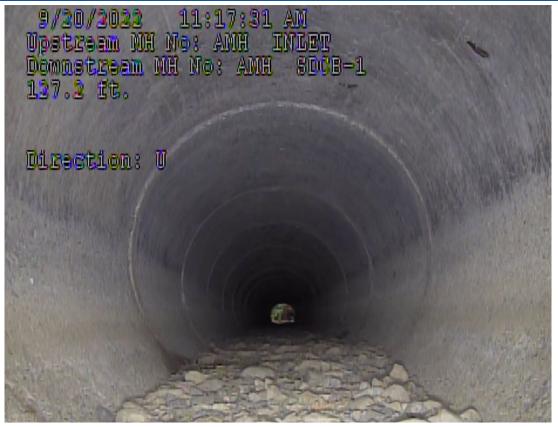
Figure 5-29: Rock and Sediment Accumulation in 6<sup>th</sup> Street RCP

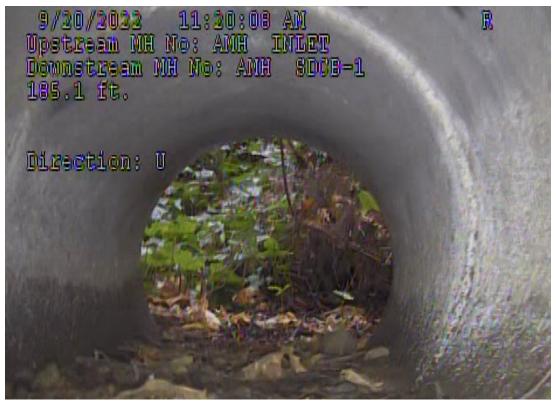
Figure 5-30: Overgrowth and Sediment Accumulation at Upstream end of 6<sup>th</sup> Street (24-inch RCP)

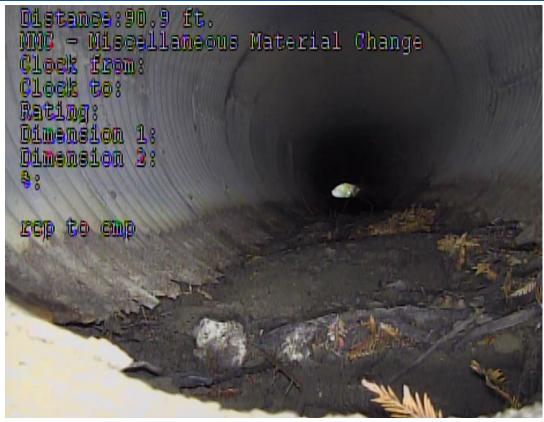
Figure 5-31: Corroded CMP Bottom at Transition from RCP to CMP (6<sup>th</sup> Street Outfall)

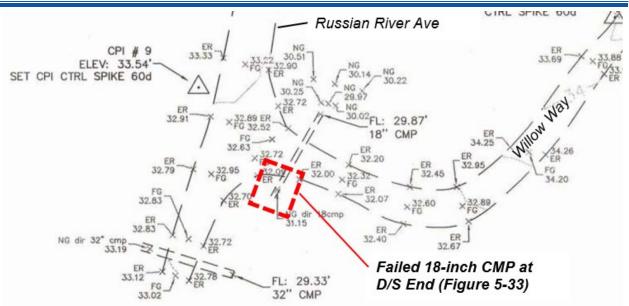
Figure 5-32: Willow Way Culverts

The full length of the 32-inch CMP was inspected. It is generally clear of blockage and in fair condition. This culvert transitions to a 36-inch HDPE approximately 20 feet from its upstream end. There is some corrosion along the invert of the CMP. This culvert has been identified as undersized and is already part of the Willow Way capacity CIP.

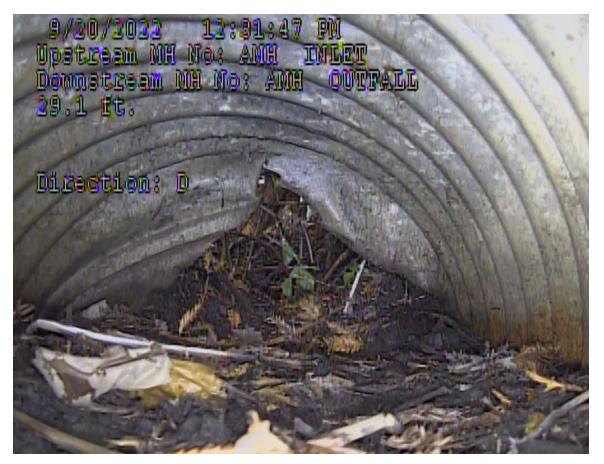
Figure 5-33: Failed 18-inch CMP Culvert at Willow Way (Downstream End)

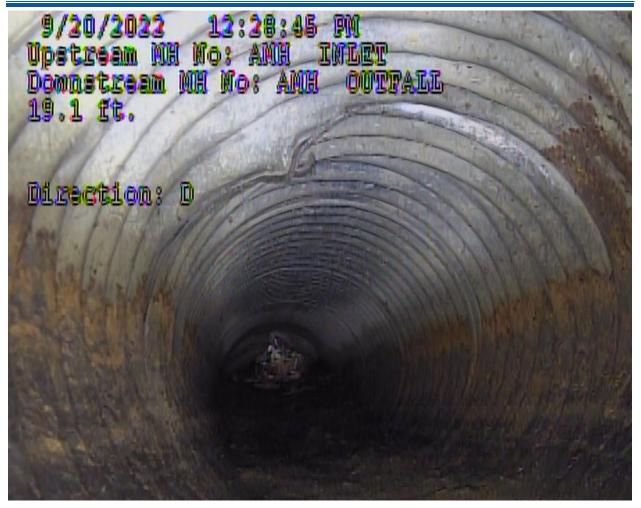
Figure 5-34: Creasing/Flexure and Corrosion in 18-inch CMP Crossing Willow Way.
