APPENDIX H
ADDITIONAL HYDROLOGIC ANALYSIS

TOLAY LAKE REGIONAL PARK INTERIM LAKE MANAGEMENT PLAN

TOLAY LAKE DRAFT COMPARISON REPORT

ATTACHMENT 1
Tolay Lake Regional Park
Staff Gauges and Culvert Inspection Photo Log
November 3, 2017

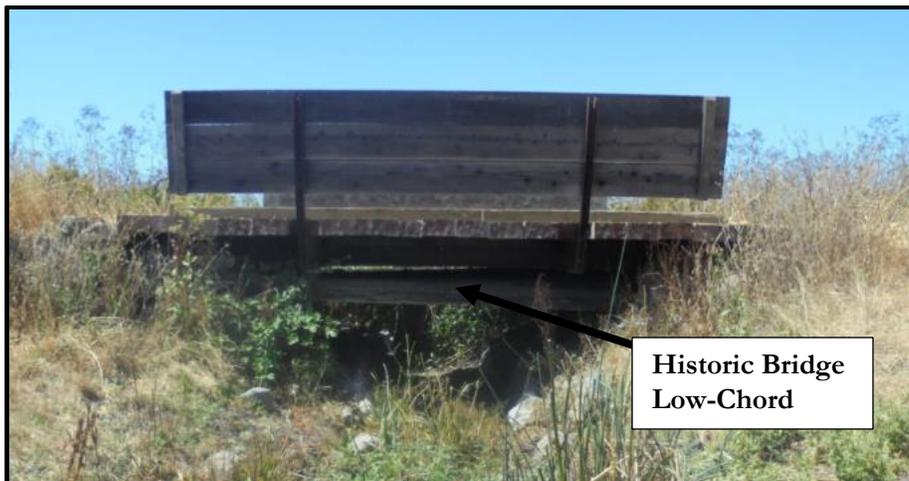
This measure would dramatically improve drawdown times during large flood events. The wood beam low chords (see image below) impede flows when the lake WSE is greater than ~216.5. These low chords are not part of the existing bridge and thus have no effect on the historical character, structural stability or load bearing capacity of the existing bridge.

- iv. Remove the wood beam low chords from the historic wood farm bridge.

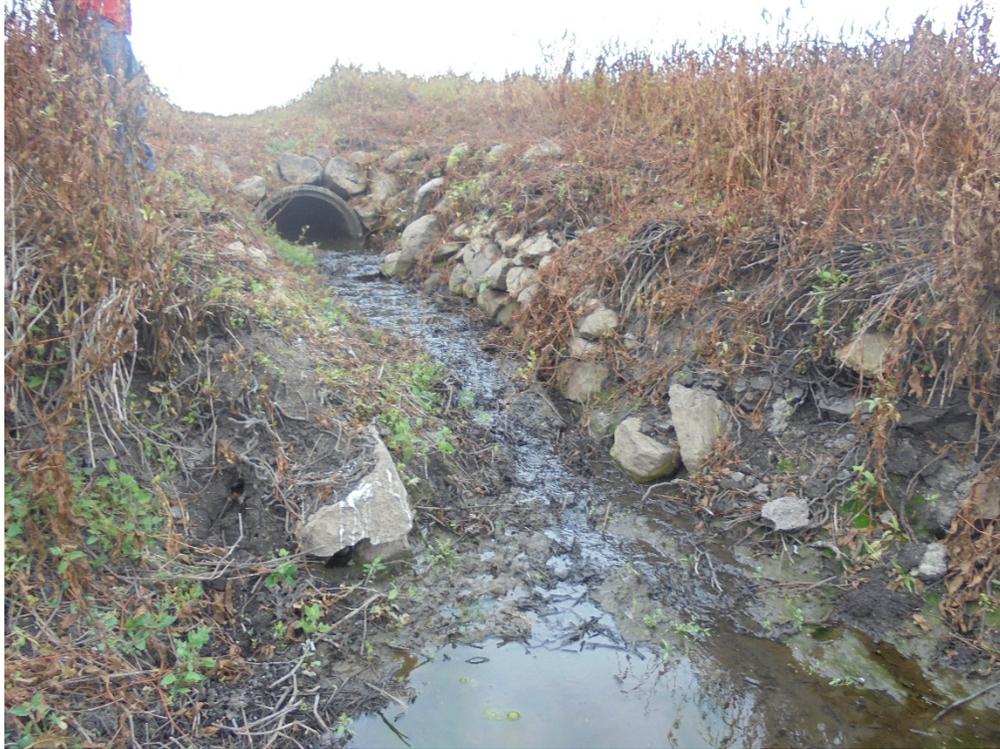
8. Inlet of horseshoe culvert looking south, flow is “backwards” from southeast to northwest.

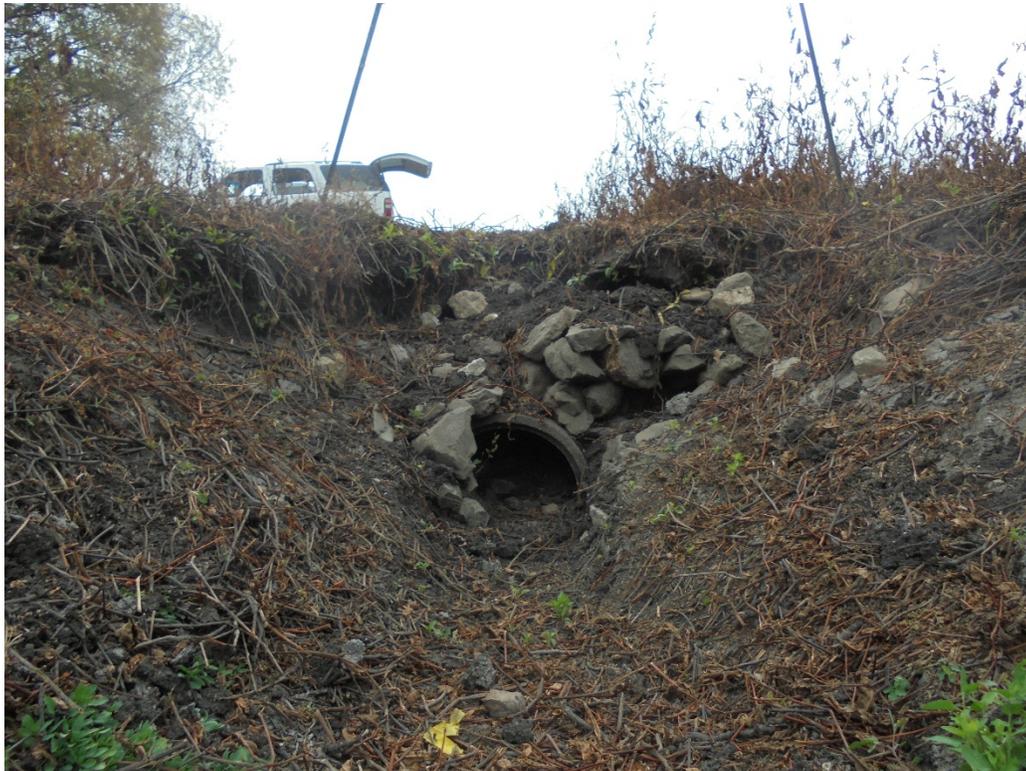
9. Tolay Creek causeway culvert inlet, looking southeast.

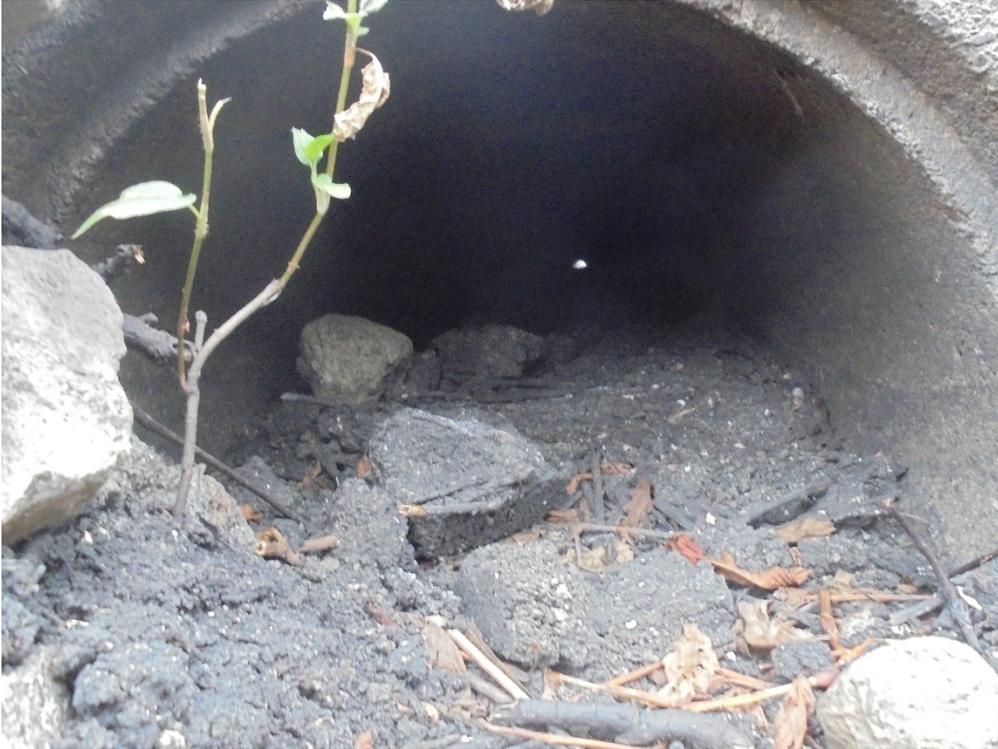
10. Looking southeast through Tolay Creek causeway culvert, ~70% full of sediment, but appears to be in good conditions.

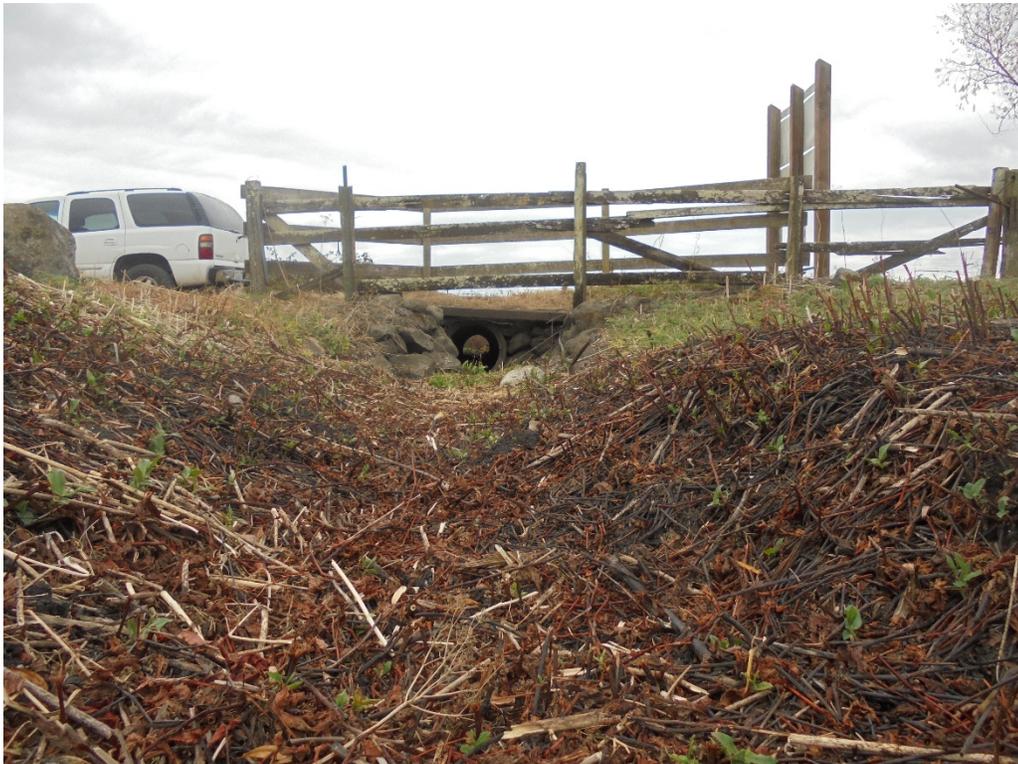
11. West ditch causeway culvert, looking southeast.

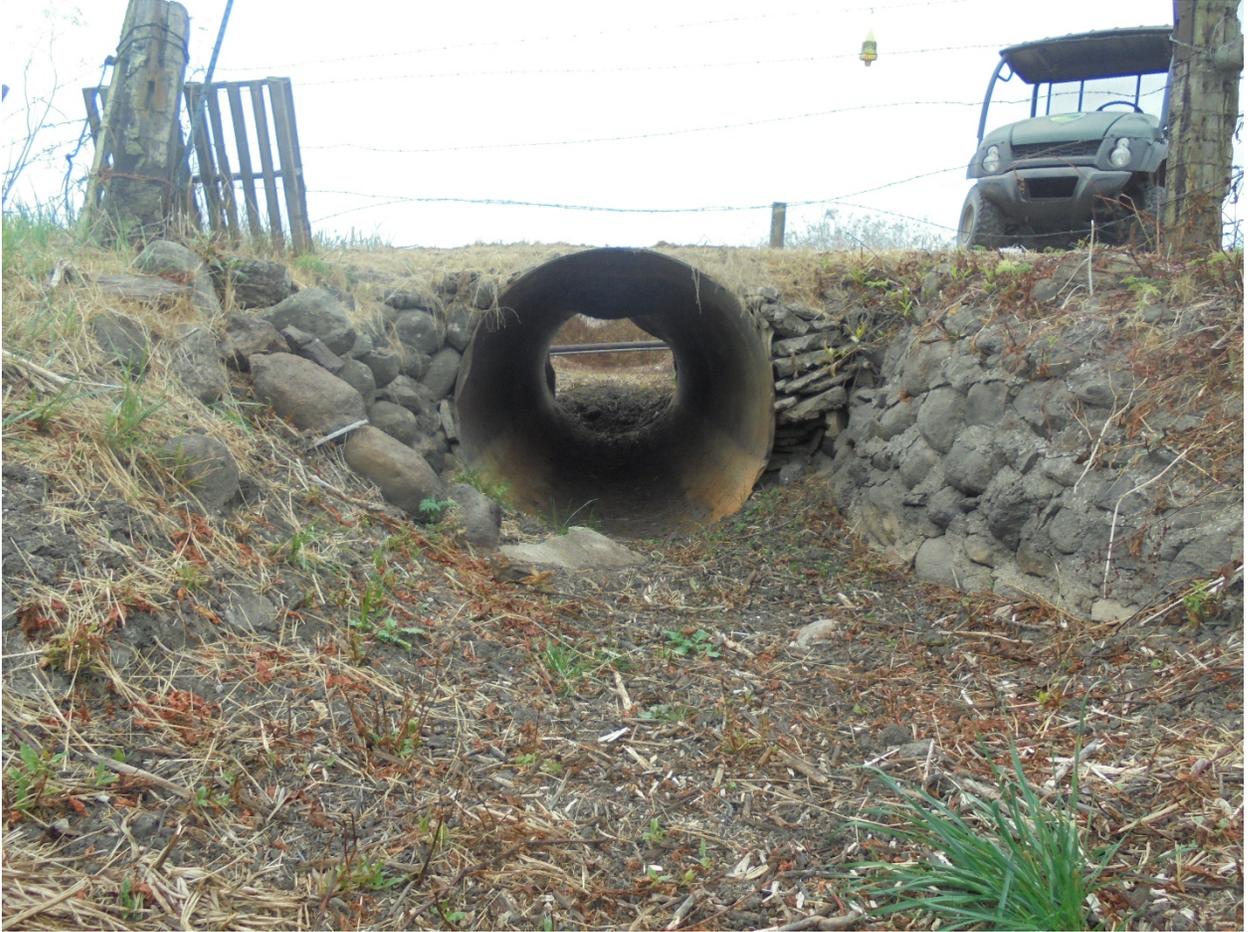
12. North Creek channel causeway culvert, looking southeast; notice top of culvert concaving from vehicle loads.
