Harbor Coastal Trail Traffic Analysis

Prepared for the
County of Sonoma

Whitlock & Weinberger Transportation, Inc.

March 1, 2011

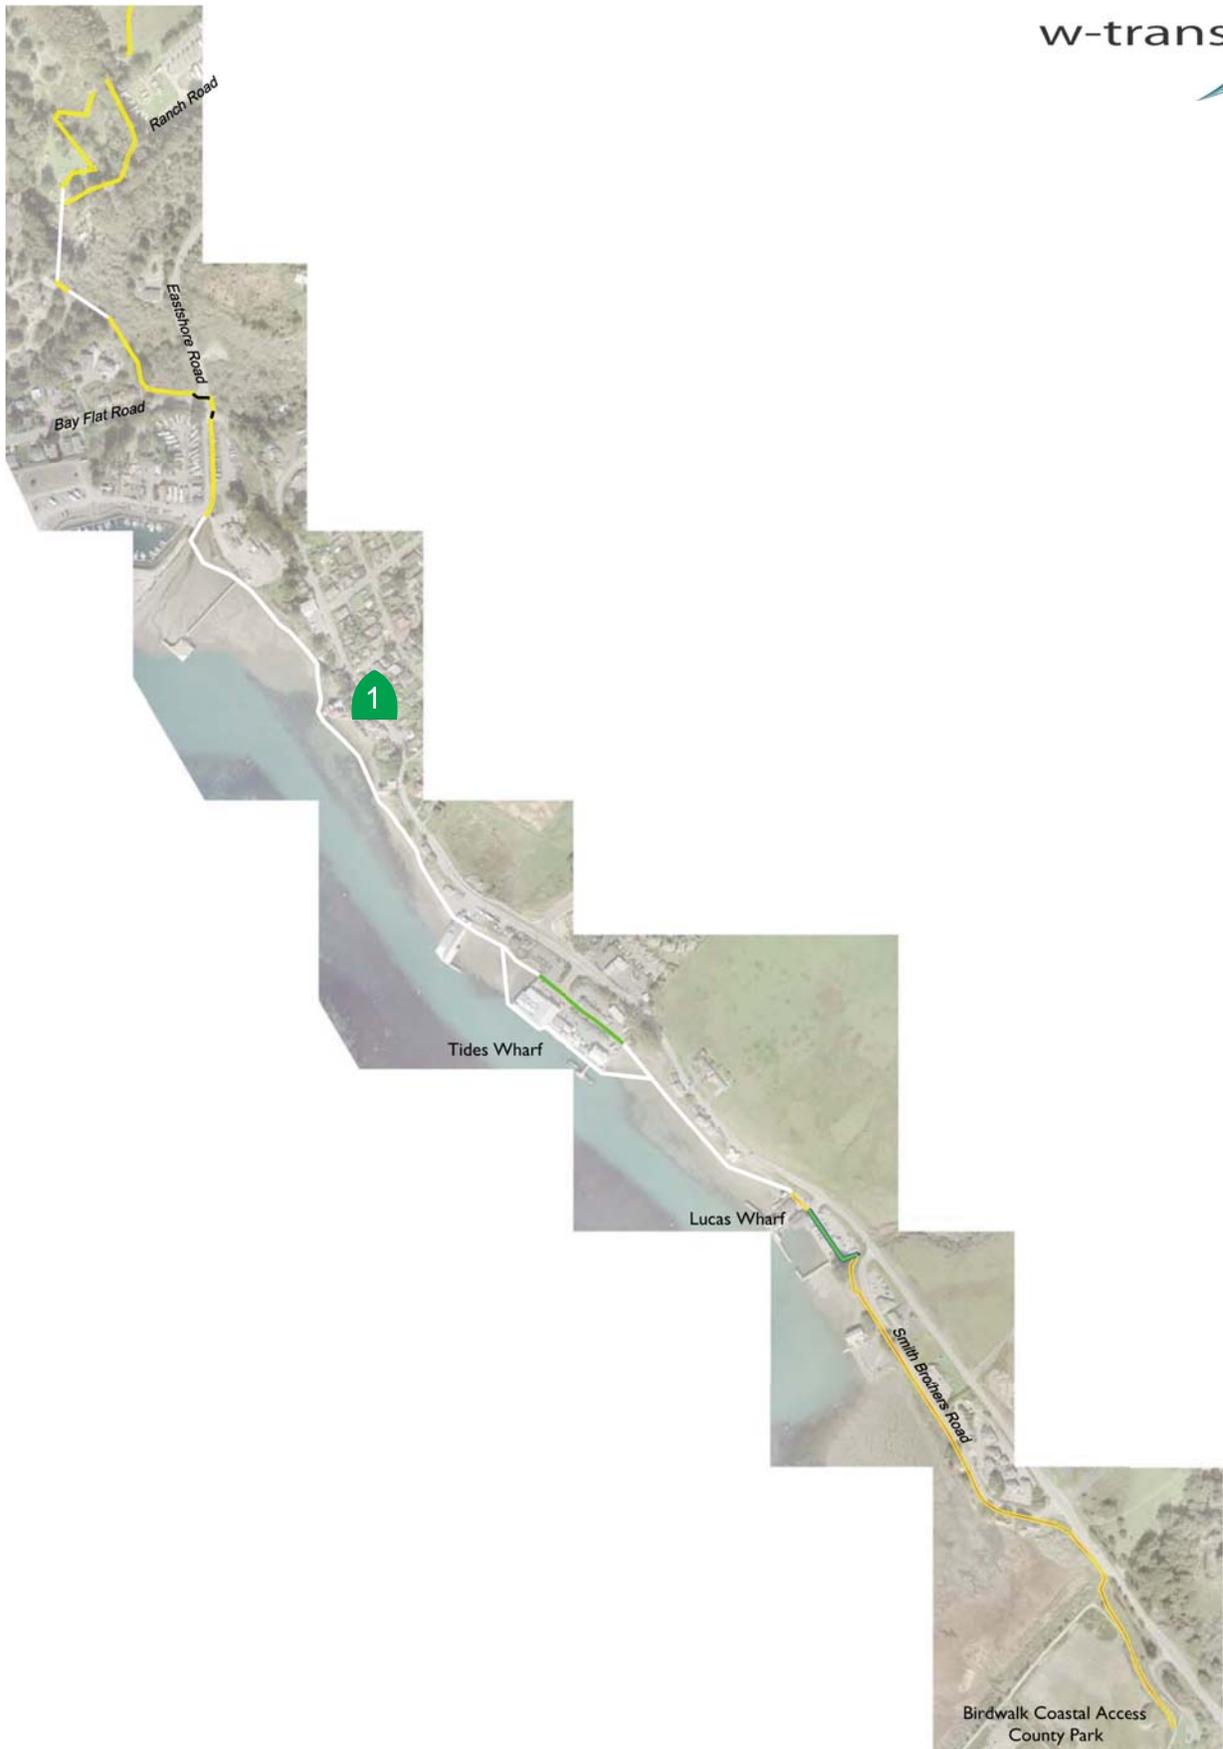
The Harbor Coastal Trail project is intended to create approximately two miles of Class I shared use trail along the town of Bodega Bay's east harbor shoreline, extending north of Bodega Bay from State of California parklands near State Route 1 (SR 1) and Ranch Road, to the south of town near Bird Walk Coastal Access County Park, which is south of Smith Brothers Road, as shown in Figure 1.

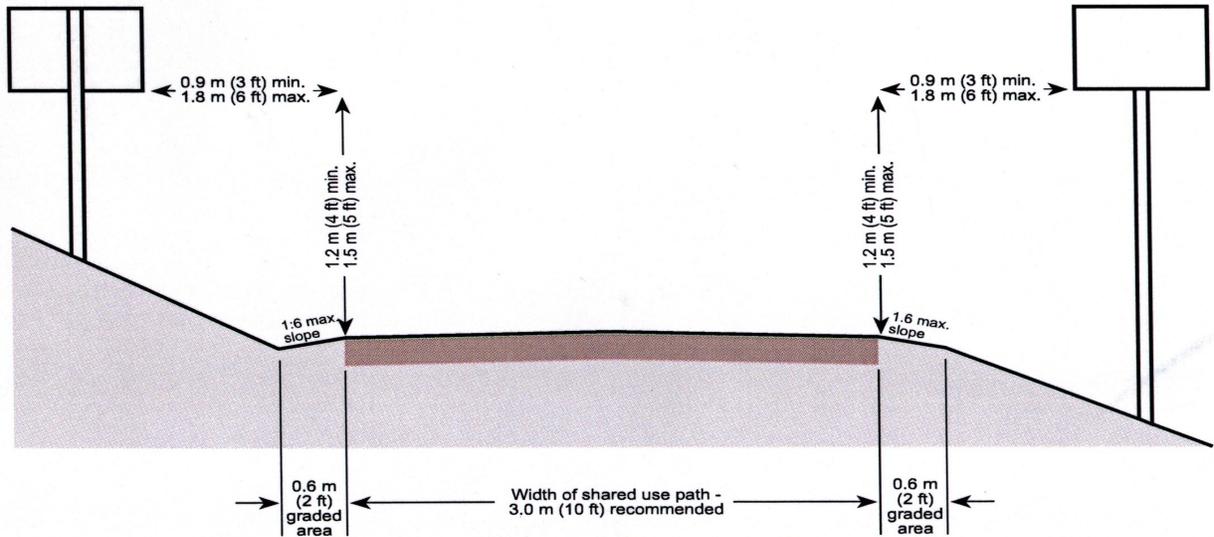
Plate I Cross Section of Two-Way Shared Use Path on Separated Right-of-Way

Class I Bikeways/Share Use Paths are intended to be shared by bicyclists and pedestrians, constructed of all-weather surfaces, typically a minimum of eight feet in width (though ten feet is preferred), and separated from adjacent streets by an open space at least five feet in width or equipped with a barrier. The AASHTO Guide and the HDM include more specific recommendations on the design of this separation area, including a two-foot minimum graded area in order to provide clearance from obstructions such as signposts, delineators, and drainage inlets. The remaining separation area is intended to prevent path users from unintentionally entering the street travel way and to reinforce the concept that the path is an independent facility. If a barrier is used, AASHTO recommends a minimum height of 42 inches, while the HDM lists 54 inches as the minimum path barrier height. A summary of some of these dimensions is included in the AASHTO Guide figure shown in Plate 1.

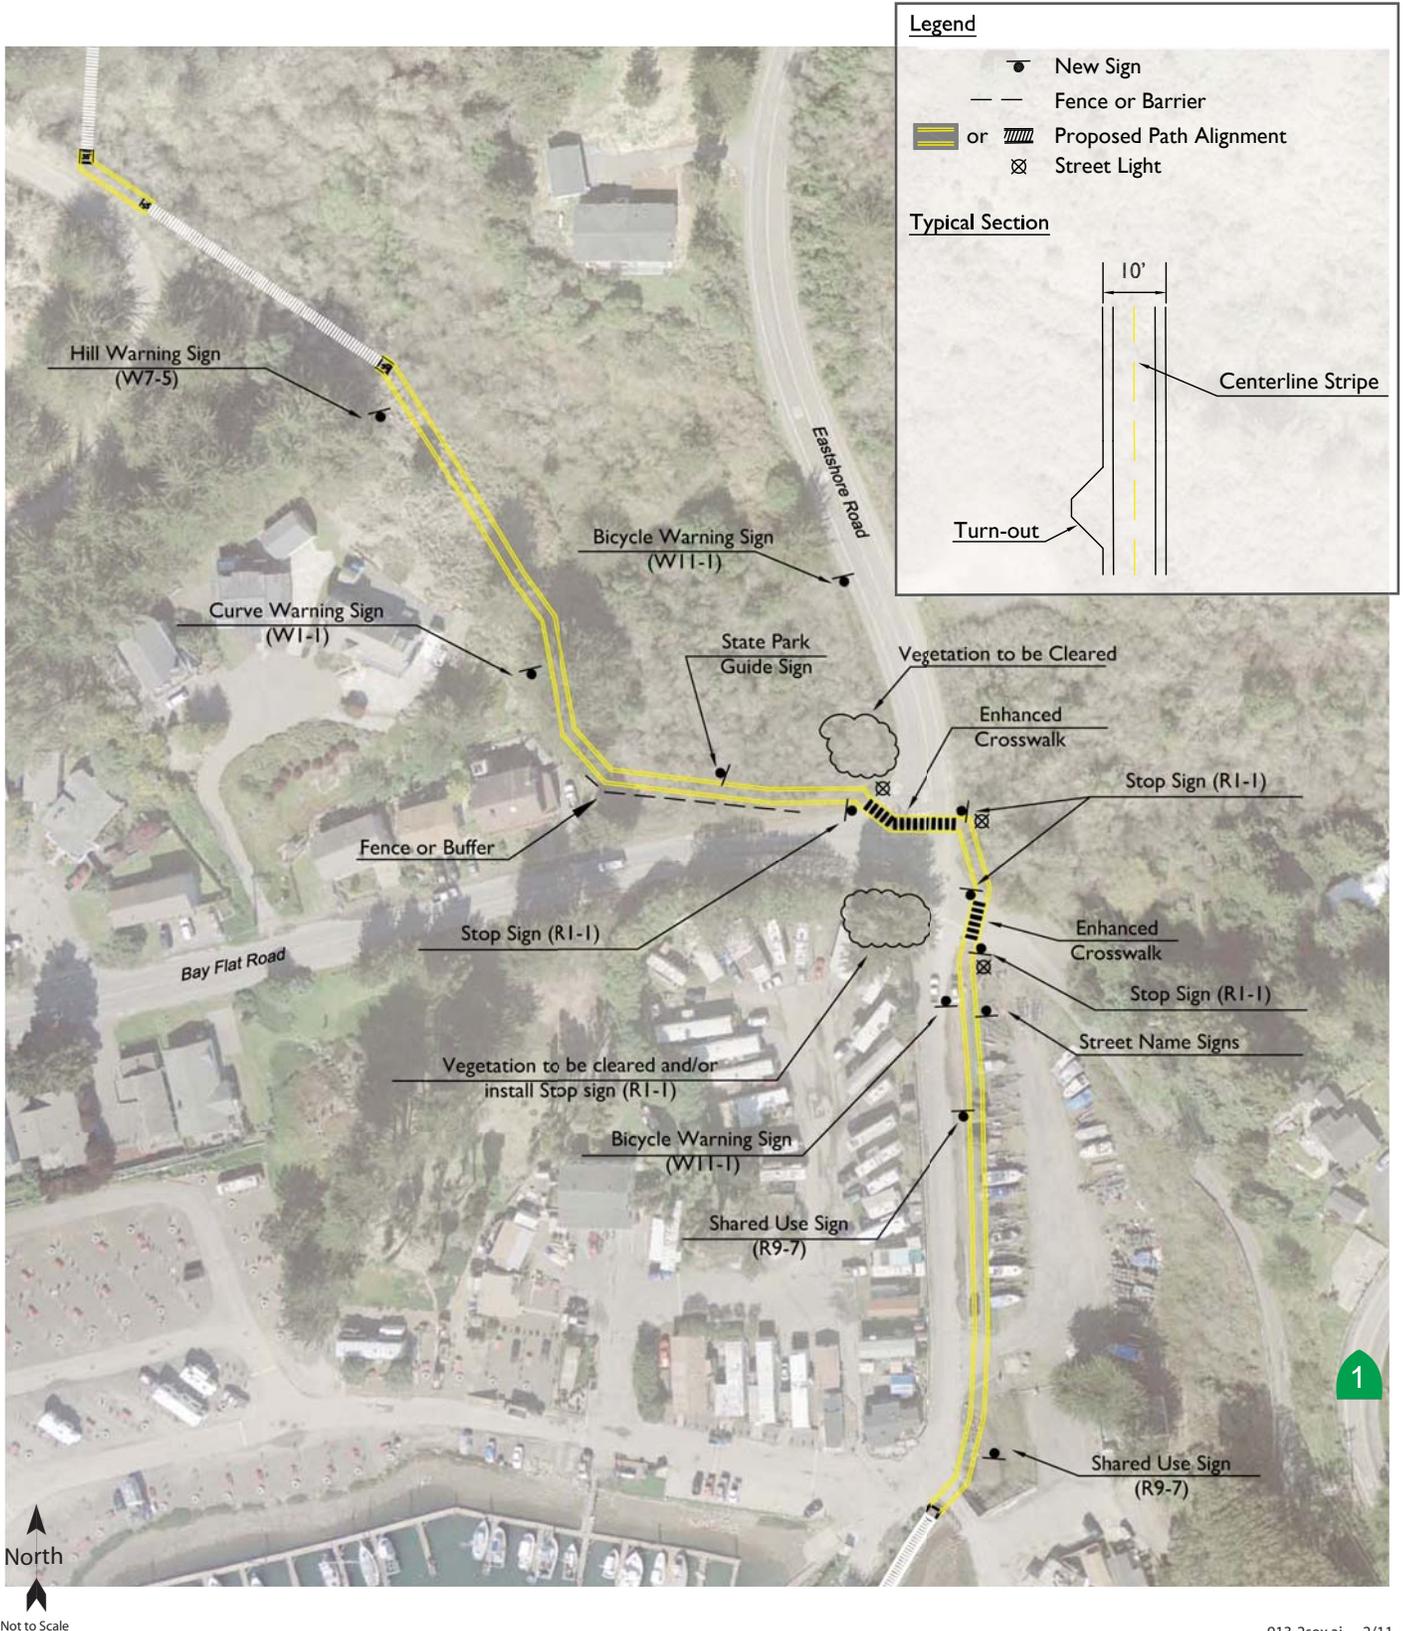
modes of travel. The following traffic improvements shown in Figure 2 are recommended to provide guidance:

- Street lighting should be provided to illuminate the crosswalks, with one streetlight placed to illuminate the crossing of Bay Flat Road and two streetlights placed to illuminate the crossing of Eastshore Road, including one on either side of the street.

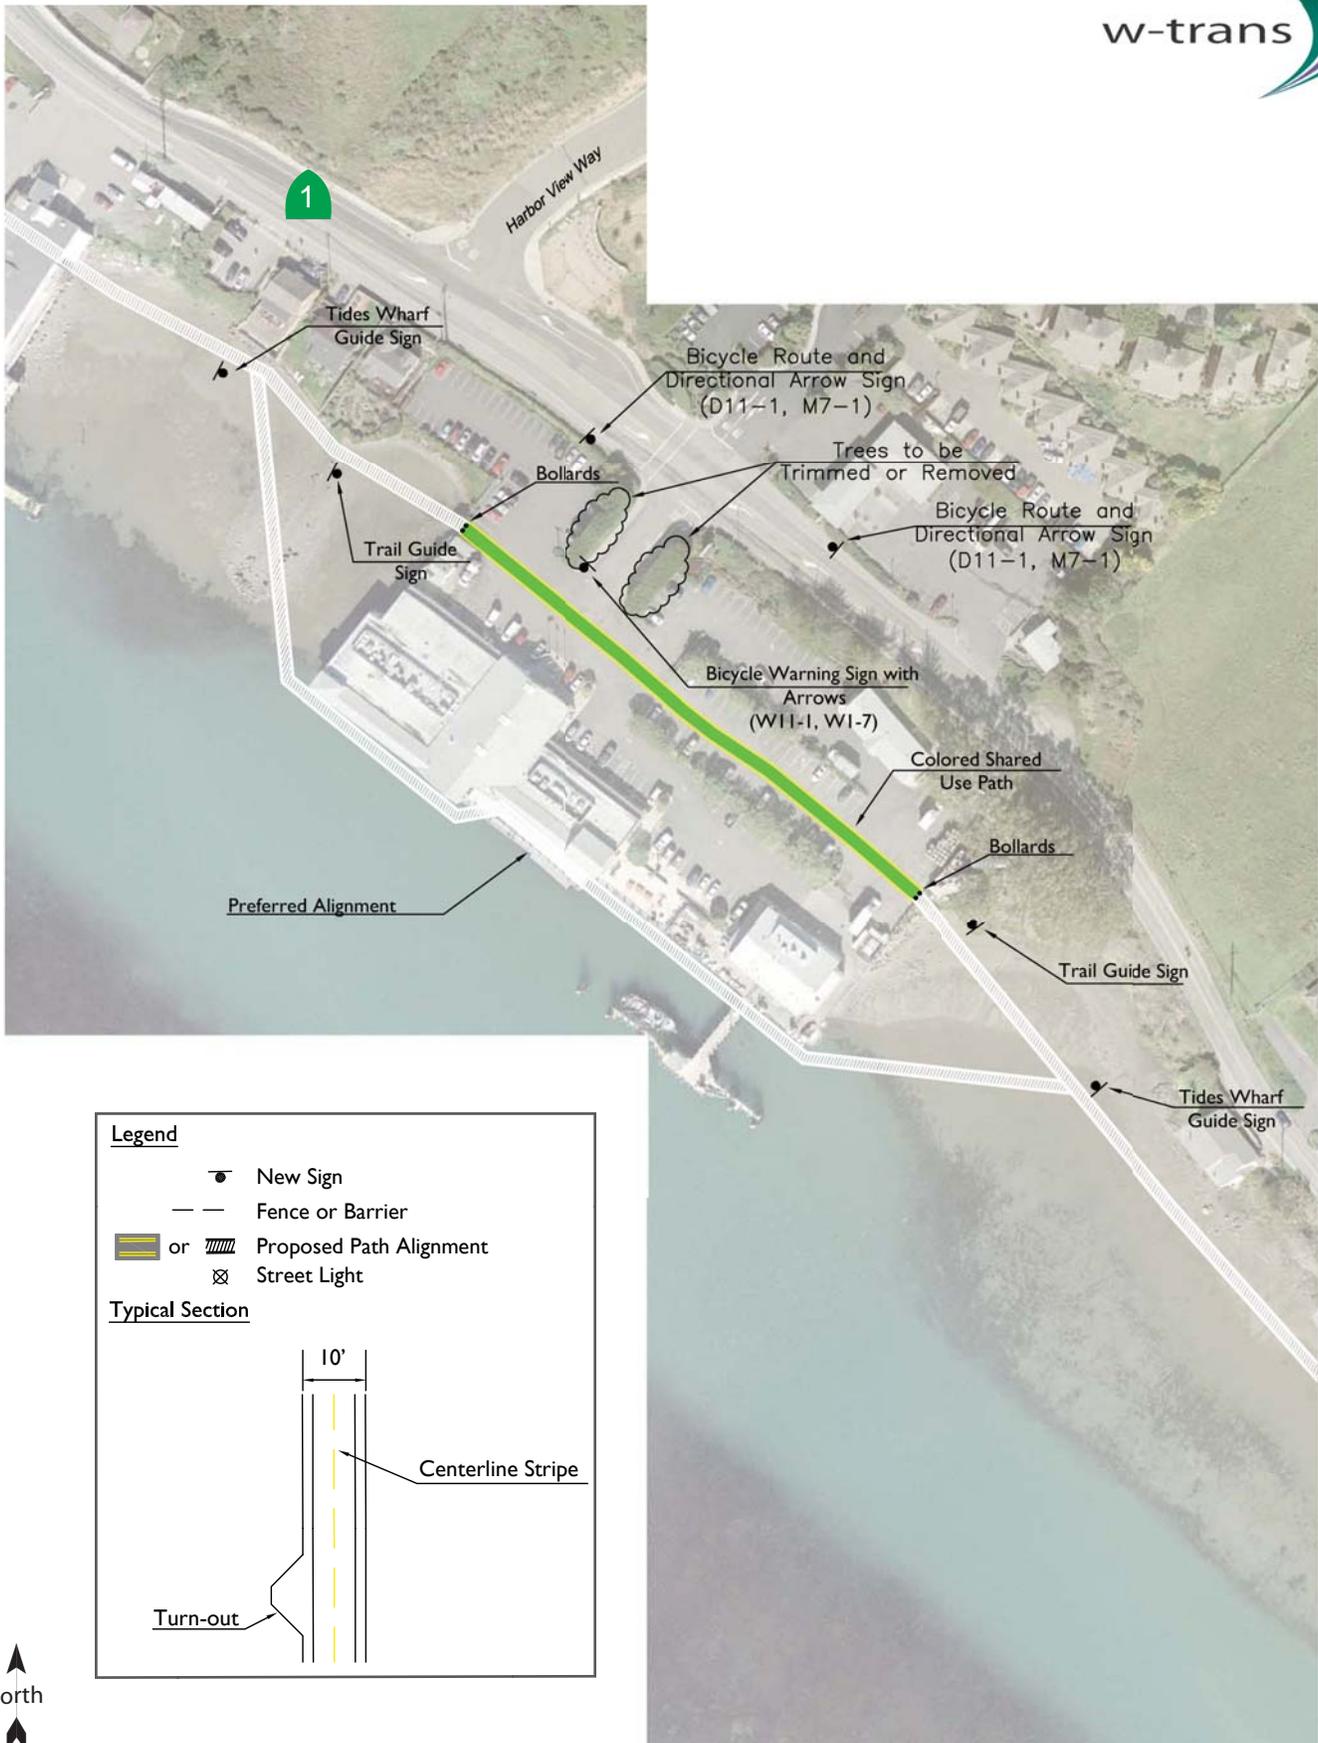
Following are recommendations which are also shown in Figure 3:

- Due to the high rate of collisions on SR 1 within the study segment bike lanes or a shared use path are not recommended in this location. The collision pattern could be attributable to distracted drivers and maintaining a maximum degree of separation between motorists and path users along the state highway is recommended.

- Bicyclists would be expected to continue to use SR 1 to travel through Bodega Bay and it is recommended that they be provided on-roadway bicycle guide signs in both travel directions to alert them to the project trail, including a *D11-1 Bike Route* sign and *M7-1 Directional Arrow* sign. For southbound cyclists, these signs should be placed north of the SR 1/Eastshore Road intersection, the Tides Wharf site, the Lucas Wharf site, and both SR 1/Smith Brothers Road intersections. For northbound bicyclists similar signing should be placed just south of these intersections and sites. Such signing will provide guidance to conveniently and safely access the shared use path.

As shown in Figure 3, recommendations for the alignment and traffic controls are described as follows:

- The tidelands alignment is recommended rather than the parking lot alignment. If the path were aligned along the tidelands there would be minimal interaction necessary between path users and parking lot users. Separating these users would be safest for bicyclists and pedestrians, and also the most convenient for the motorists who would be expected to be anxious if delayed by a bicyclist/pedestrian when trying to obtain a parking space during a peak parking demand period.
- If the tidelands alignment is constructed, the path should be designed and equipped with the recommended improvements listed in the 'General' section above.

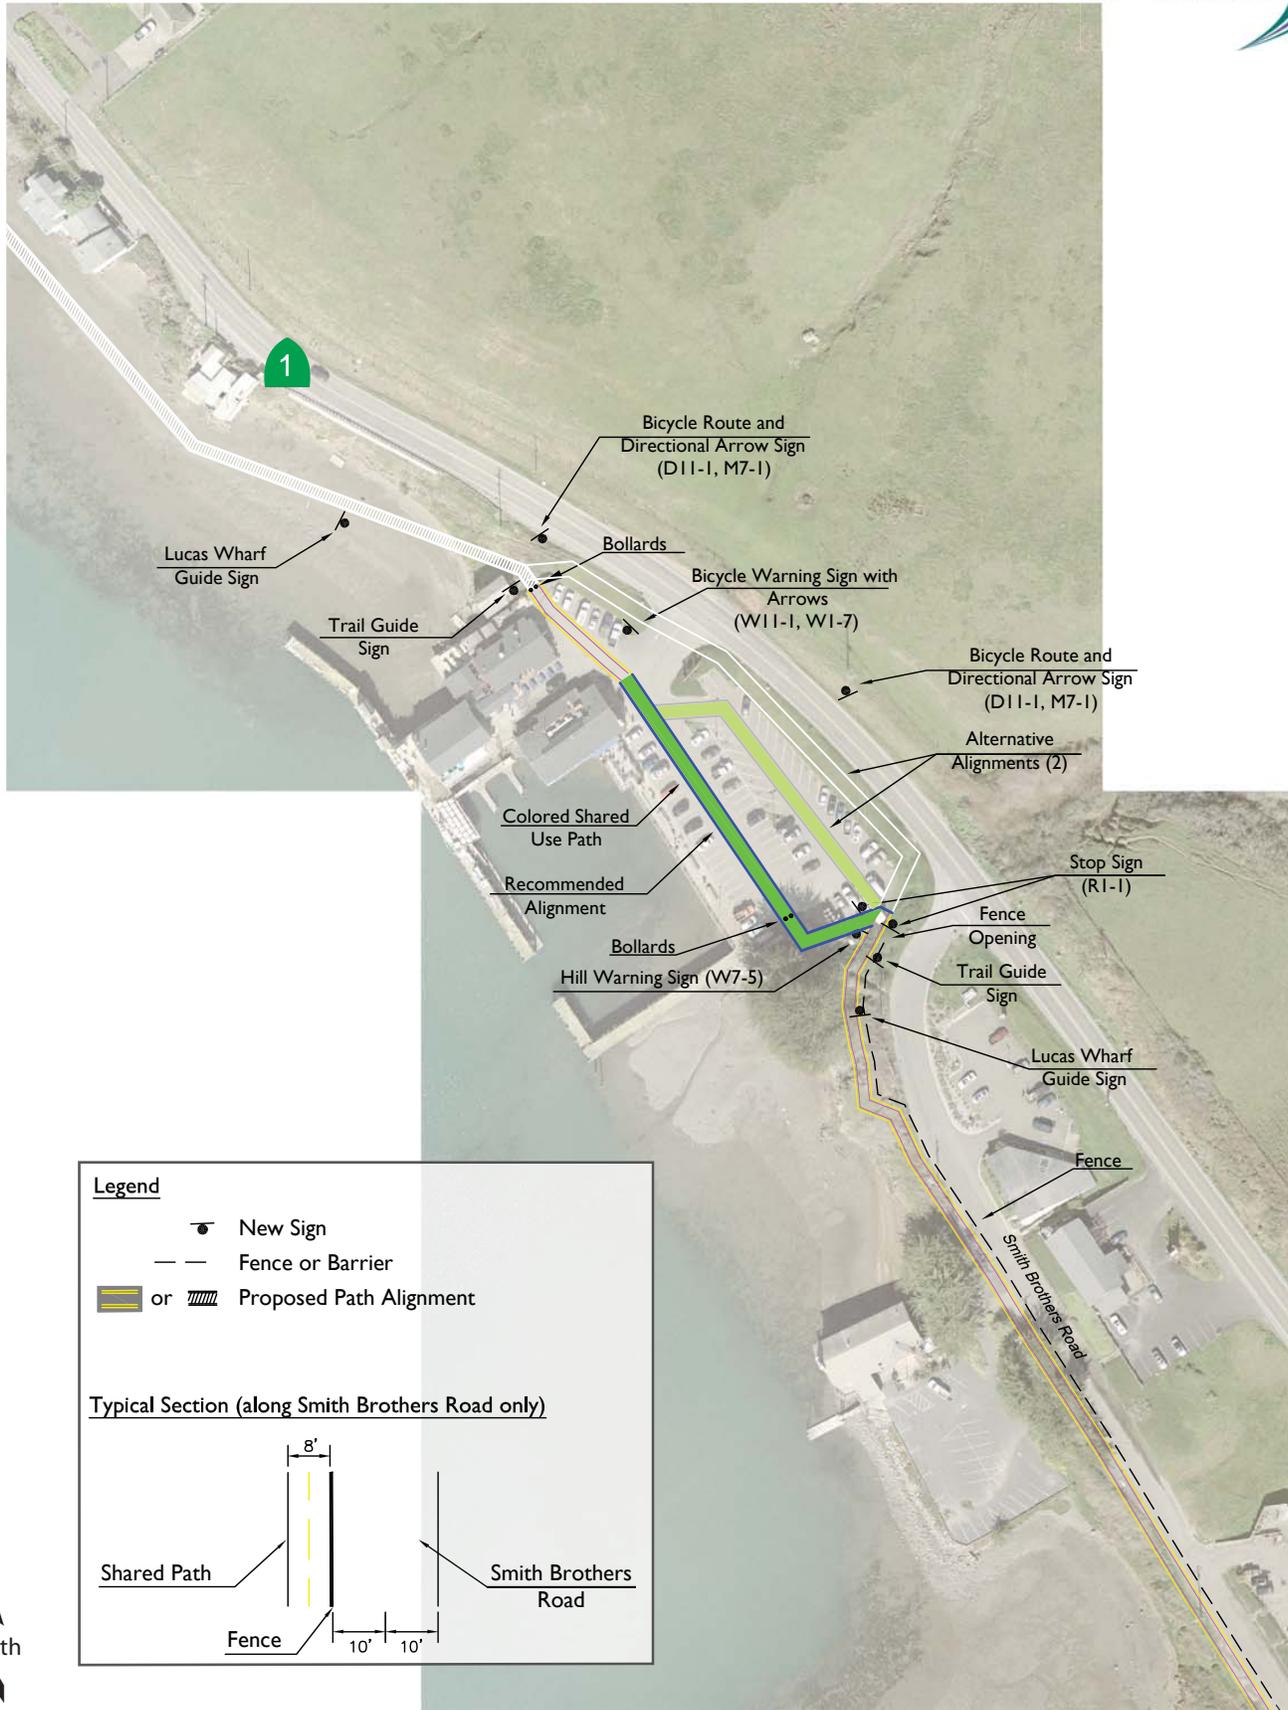
As shown in Figure 4, recommendations for which alternative to choose and also what improvements should be made for each alignment choice include:

- The parking lot alignment is recommended rather than the alignment adjacent to SR 1. If the shared use path were aligned through the parking lot there would be greater separation between path users and highway traffic, and maintaining a maximum degree of separation between the motorists and path users along the state highway is recommended.

The following improvements are recommended to ensure that bicyclists can safely approach and cross the Lucas Wharf parking lot:

- The seven recommendations made for the Tides Wharf location should be implemented at the Lucas Wharf location.
- The parking lot path alignment should be shifted west, eliminating the two turns just south of the driveway, with the path located in the drive aisle closer to the harbor. This shift is safer for path users because it moves them further from the Lucas Wharf sign/sight obstruction.
- The grade separation between the parking lot and Smith Brothers Road to the south appears to exceed ADA requirements and a switchback alignment is proposed in order to provide some connection to Smith Brothers Road, which is recommended.

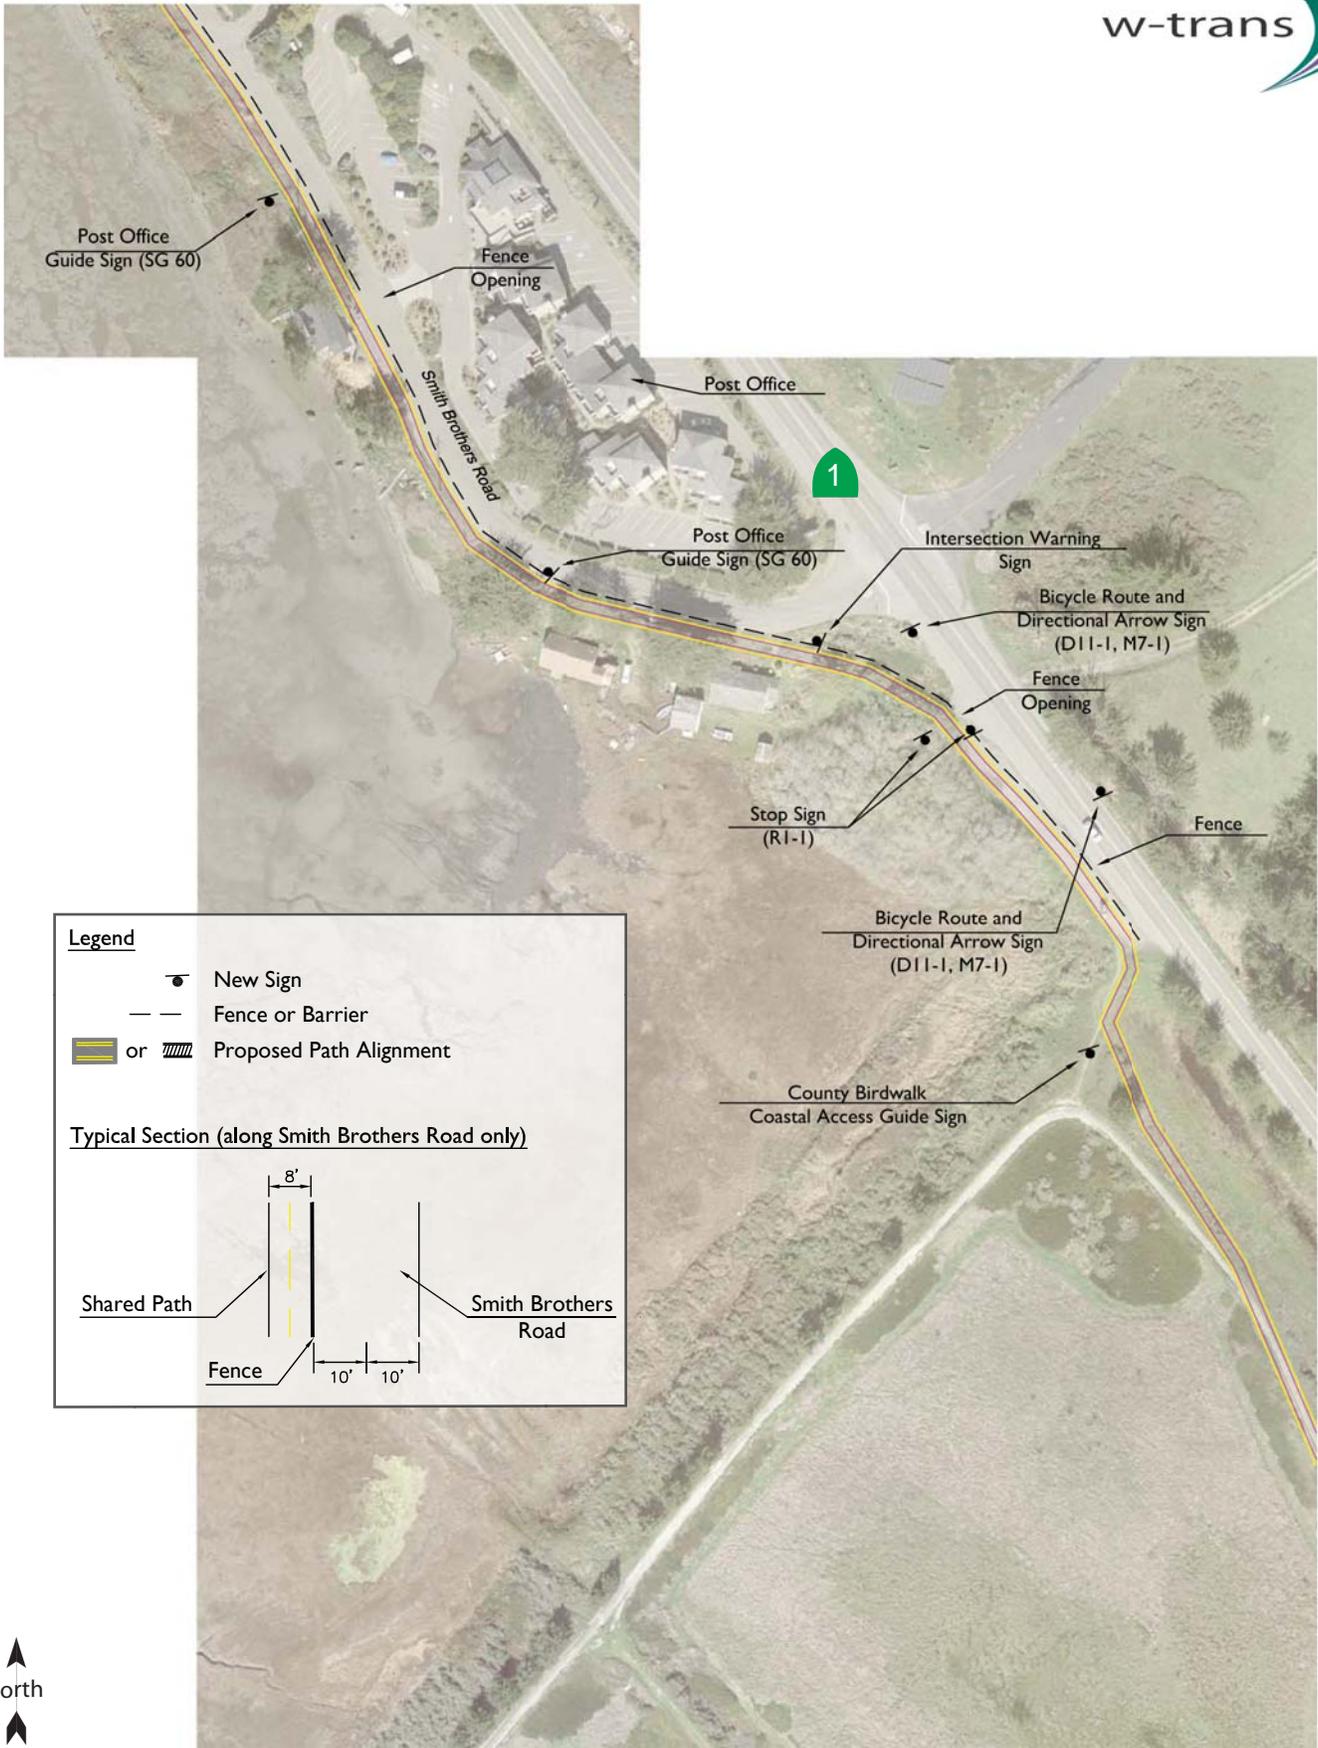
- A ten-foot wide path is recommended along Smith Brothers Road, though an eight-foot wide path may be necessary due to right-of-way or cost constraints. The path should be equipped with a 42-inch high fence to separate the path from the road. Access points through the fence should be provided near the Bodega Coast Inn driveway, the Post Office and where the path adjoins the Lucas Wharf parking lot segment.
- Alternatively, bike lanes are recommended on both sides of the street only if the shared use path cannot be accommodated.
- Stop signs and limit lines should be installed on the path at the intersection of Smith Brothers Road (south)/SR 1.

- Two-way travel is not always understood by multi-use path users which can lead to conflicts as faster moving cyclists attempt to pass slower moving cyclists or pedestrians. A dashed centerline stripe is recommended to impart this concept of two-way travel to all path users.
- The *R9-7 Shared Use Path Restriction* sign should be installed facing both travel directions, with one approximately 100 feet south of the Lucas Wharf segment for southbound path users and one approximately the same distance north of southerly intersection of SR 1/Smith Brothers Road for northbound path users.

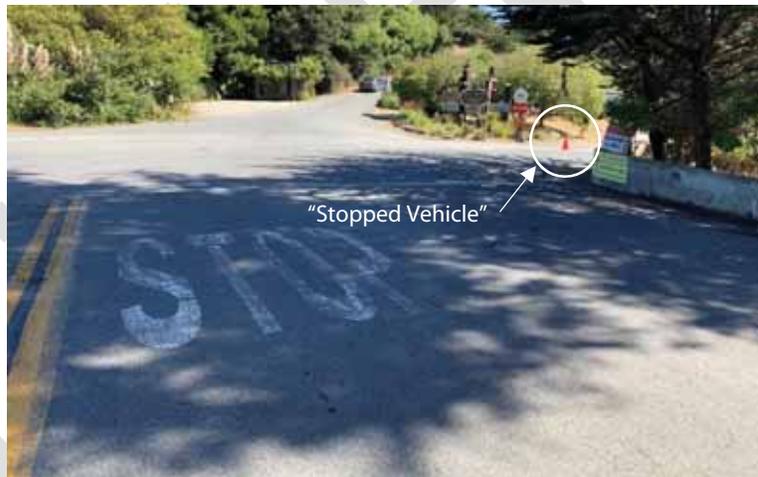
Plate 1: Sight Distance from Eastbound Bay Flat Road looking towards Northbound Eastshore Rd

Sight Distance was reviewed in the field, as shown in Plate 1, from the new proposed stop bar location on the west leg, a vehicle stopped on the northbound approach of Eastshore Road at the new stop bar location would be visible, as shown by the cone representing a stopped vehicle.

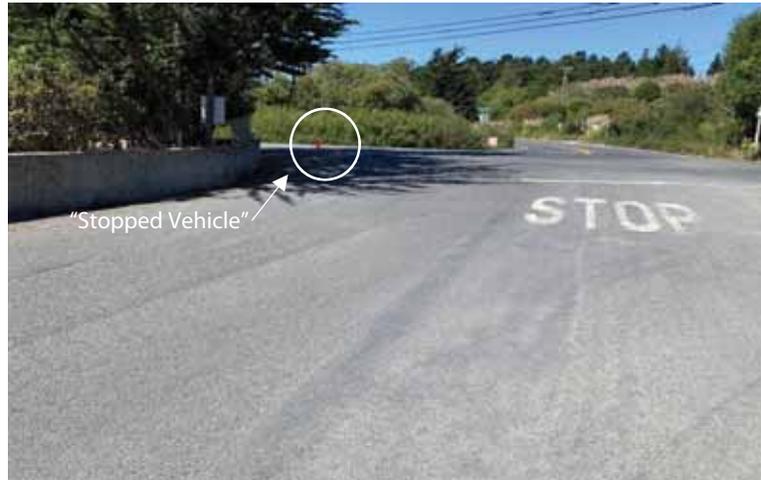
Plate 2: Sight Distance from Northbound Eastshore Rd looking toward Eastbound Bay Flat Rd

Sight distance was also reviewed for the northbound Eastshore Road towards the eastbound approach (west leg) of Bay Flat Road. As shown in Plate 2, there is sufficient sight distance to see a vehicle stopped at the new stop bar location.

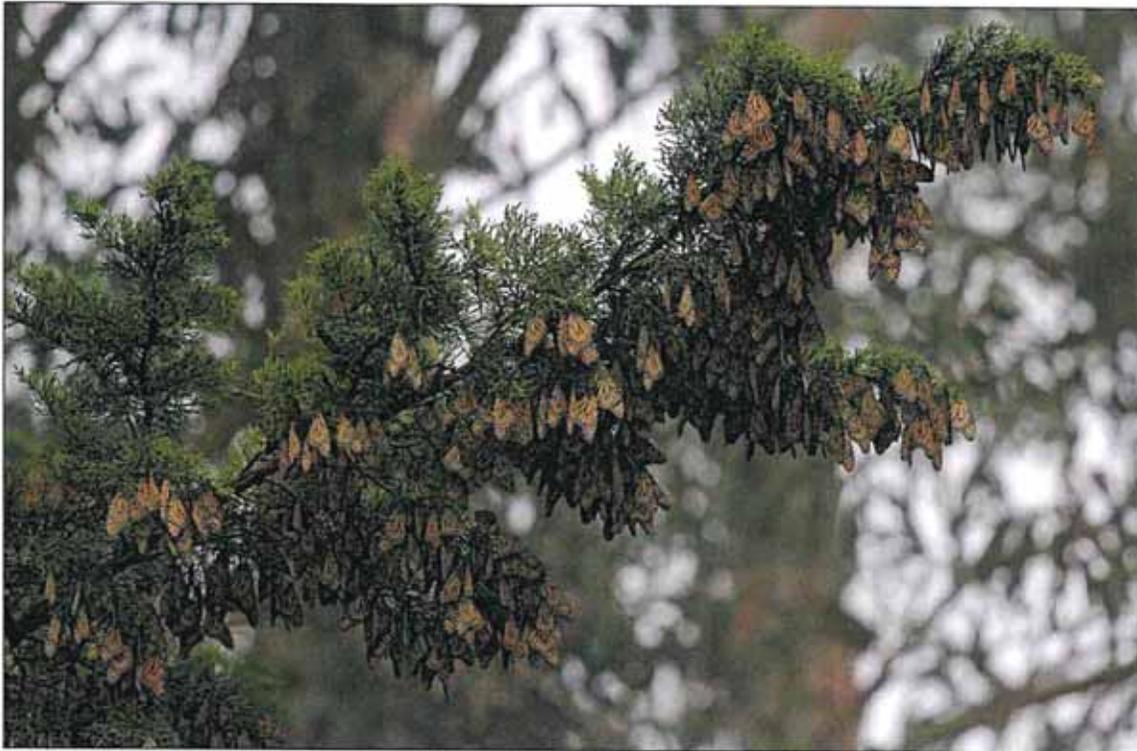
The suitability of a grove for overwintering monarchs is influenced by many factors, including shelter from wind and storms and the right amount of sunlight for the butterflies to maintain body temperature. Even seemingly small things such as a tree branch at the correct height and angle can be significant. (Photograph: The Xerces Society / Carly Voight.)

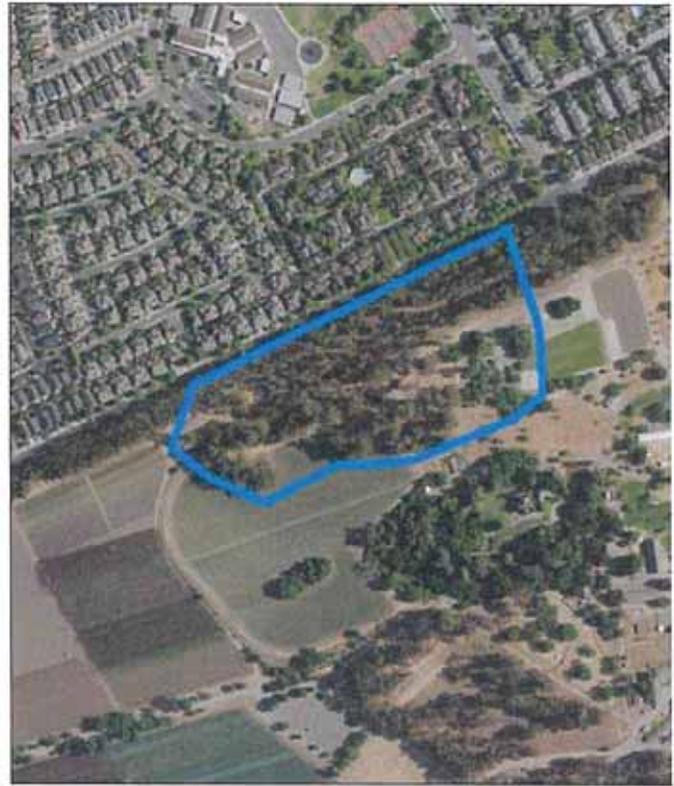
Aerial photography is easily available (for example, from Google Earth) and will make a good foundation for mapping the boundary of a site as well as the location of significant trees and other habitat components.

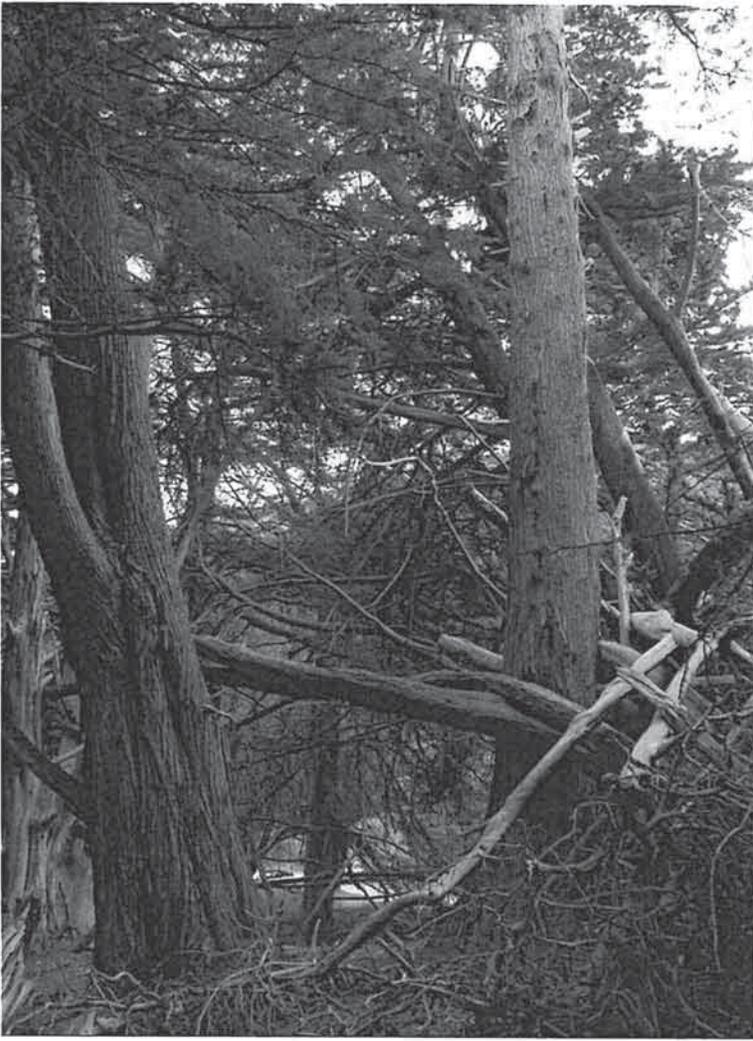
The site assessment should identify and map all features of significance for the butterflies and site management. Significant trees can be those that provide shelter or roosting branches, but also those that create hazards or need replacing. (Photograph: The Xerces Society / Carly Voight.)

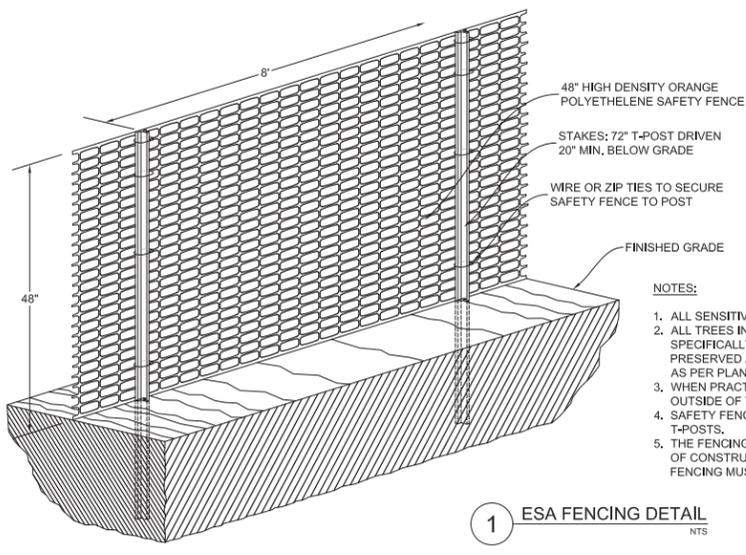
4' HIGH TREE PROTECTION FENCE PROVIDE 1' RADIUS FOR EACH INCH OF DBH UNLESS APPROVED BY ENGINEER

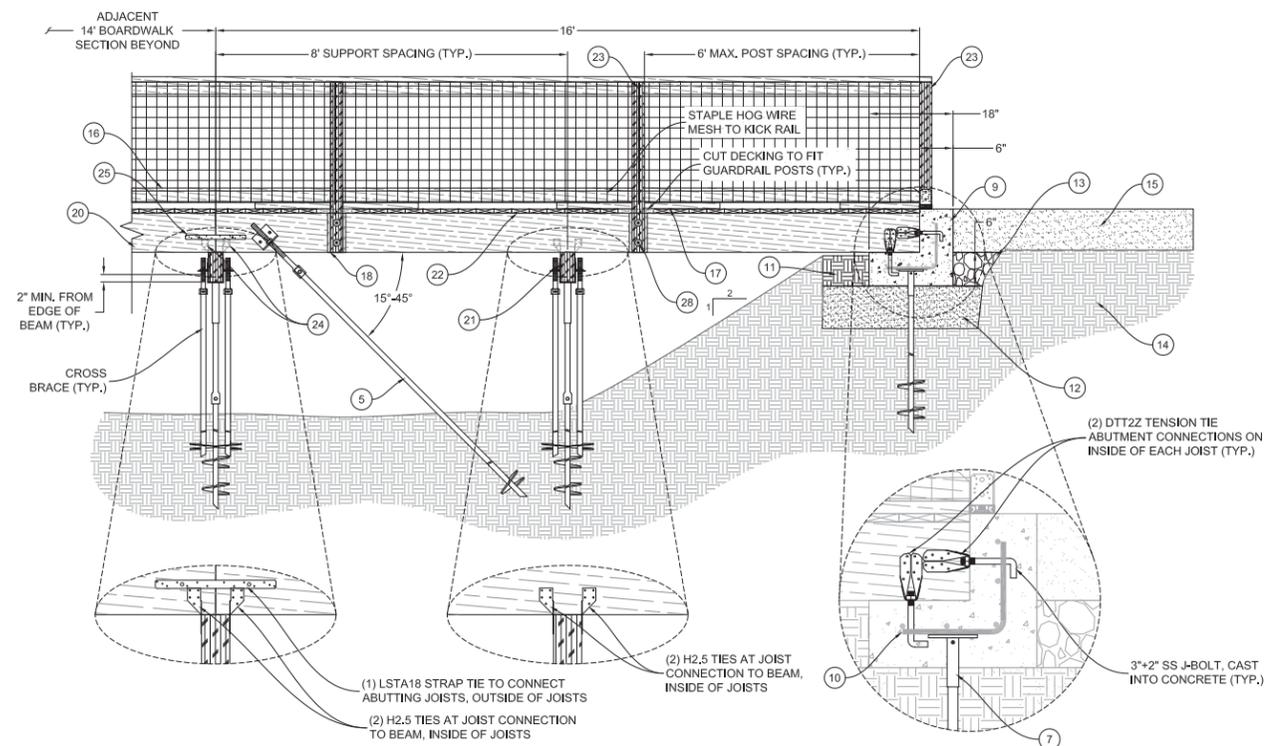
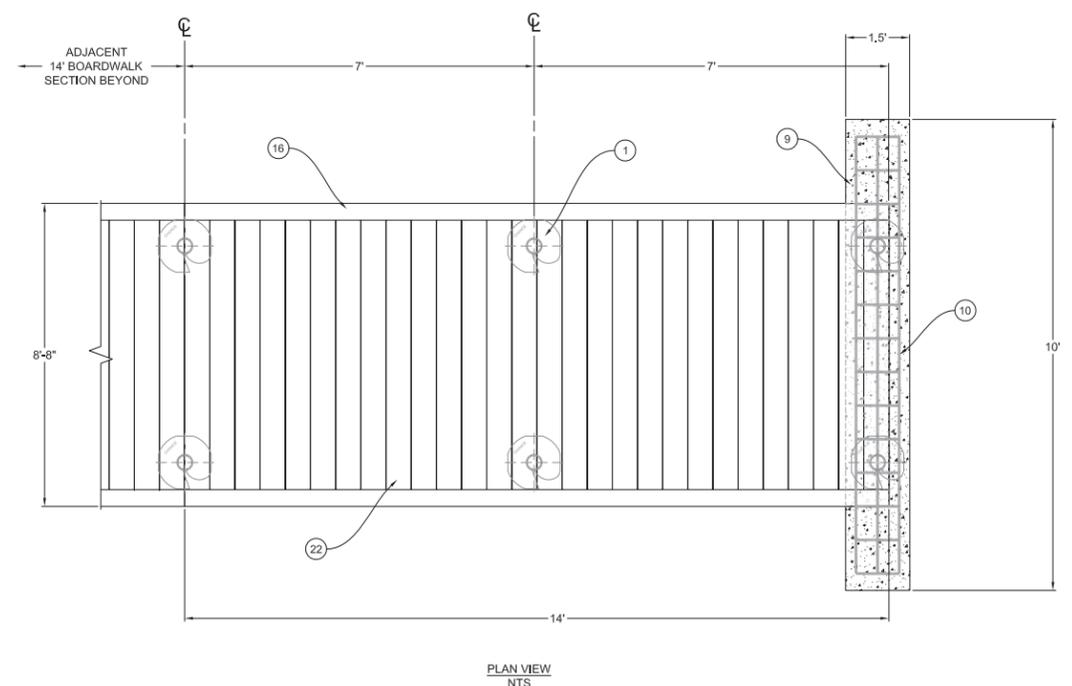
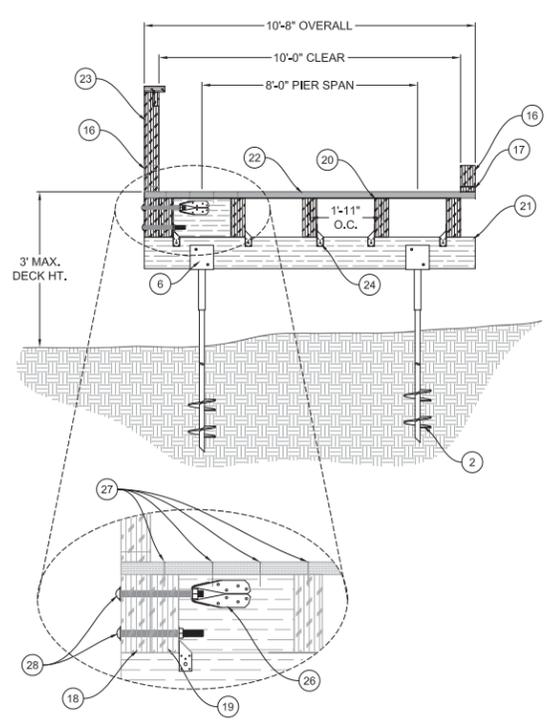
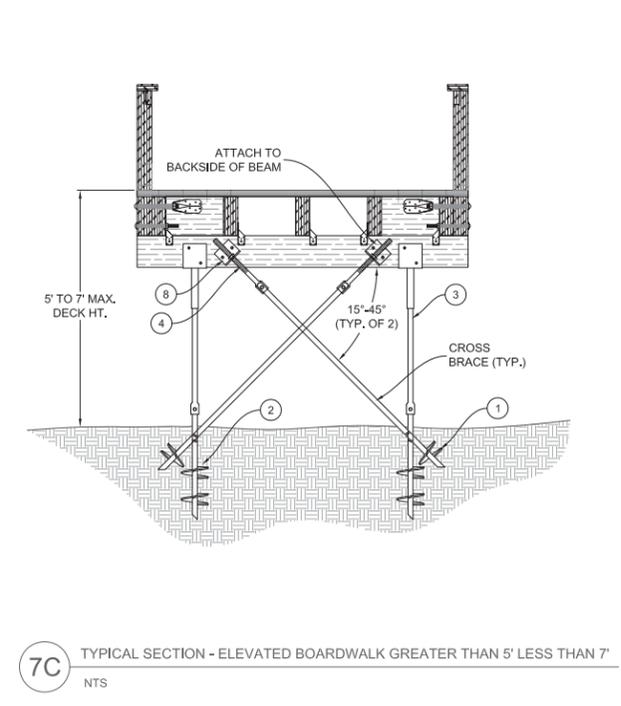
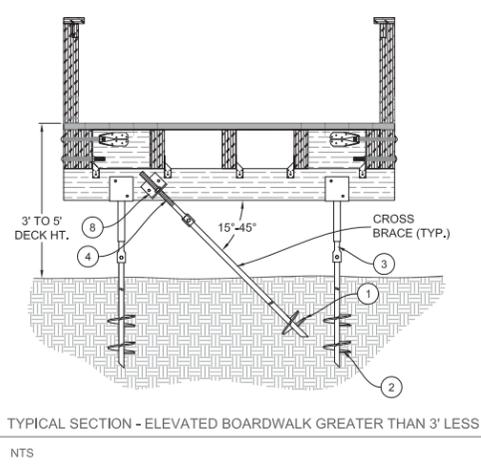
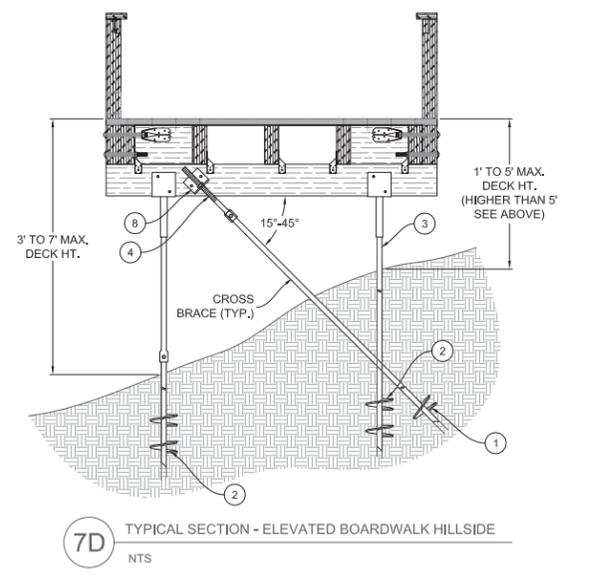
1. SINGLE HELIX LEAD SECTION, HELIX DRIVEN 4' MIN. INTO COMPETENT MATERIAL, SEE DETAIL 8, SHEET 19
2. TWIN HELIX LEAD SECTION, LOWER HELIX DRIVEN 4' MIN. INTO COMPETENT MATERIAL, SEE DETAIL 8, SHEET 19

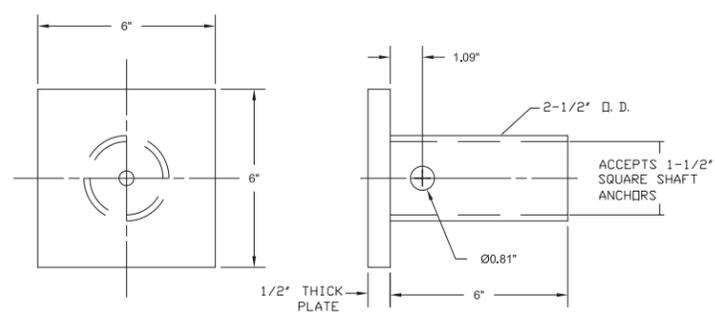
10 BEAM SEAT BRACKET
NTS

COUPLING BOLT AND NUT			
BOLT DIA.	BOLT LENGTH (MIN.)	BOLT GRADE	NUT
3/4"	4.25"	ASTM A325 TYPE 1	3/4", MATCHING HEX NUT
