# TOLAY CREEK RIPARIAN ENHANCEMENT PLAN

*November 2009*

**DEVELOPED FOR:  
Sonoma Land Trust**

**DEVELOPED BY:  
West Coast Watershed**

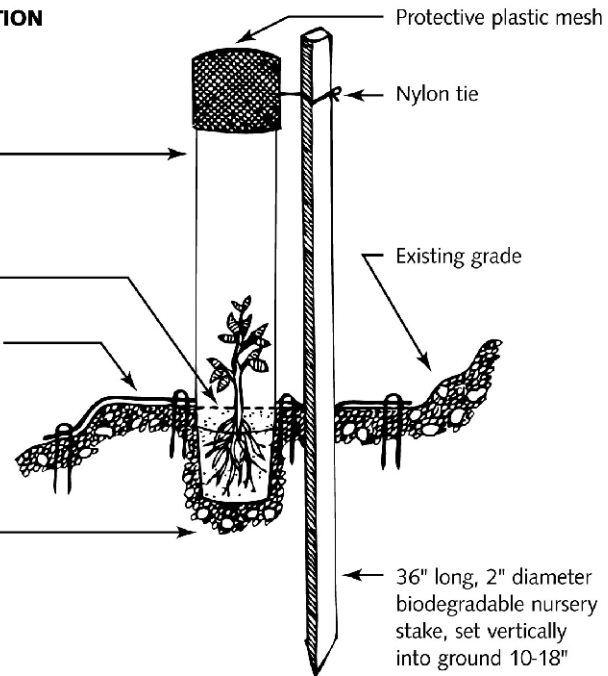
**DIRECT SEED PLANTING DETAIL**  
(not to scale)

- Install native seeds from oaks, buckeye, bay or walnut from November-February
- Install when soil is moist to 10"
- Seed depth at installation = 1-3", depending on species
- Protect plant as needed with plant protection tube and/or fabric mulch (see *Plant Protection Shelter Detail*)

Oak species and California buckeye can be planted by the direct seed method. This method entails collecting ripe seed within the watershed in the fall, and planting the seed when soil conditions are favorable during the same season. The advantage of this method is it eliminates nursery costs. The disadvantage is the seeds are subject to rot, drying up, and predation. The direct seed method depends on an adequate seed crop and may have to be performed several years in succession if seed is not available in the desired year.

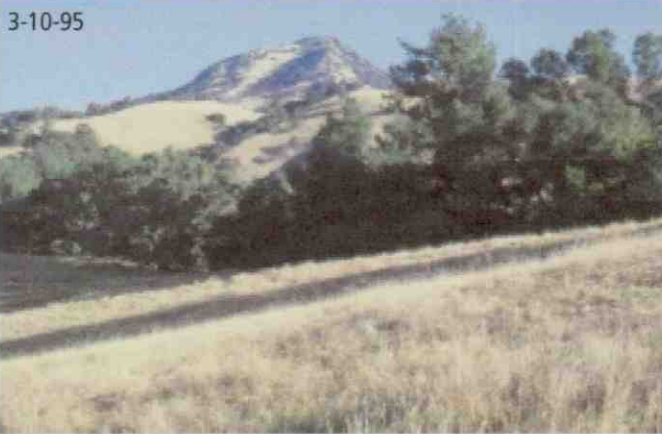
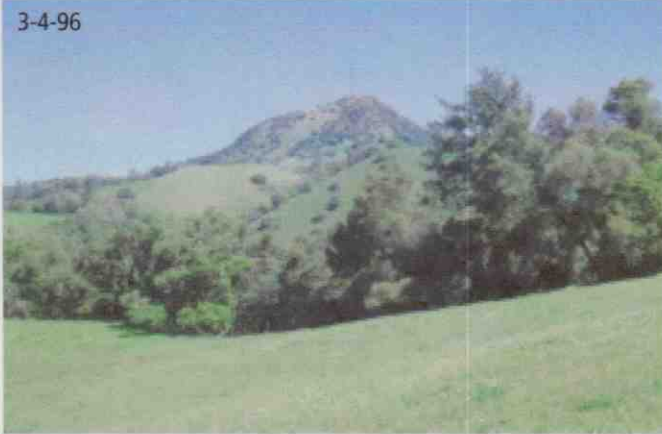
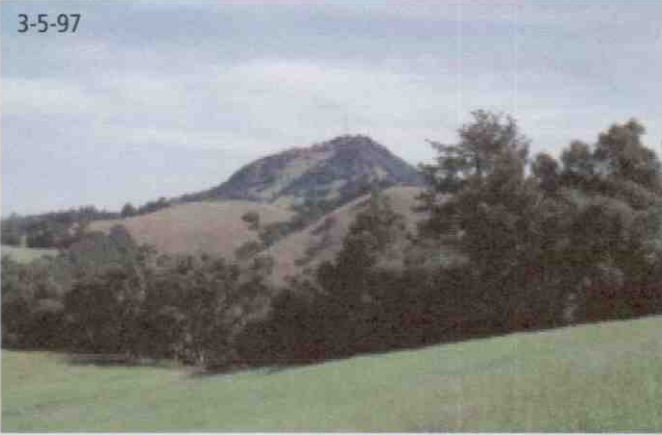
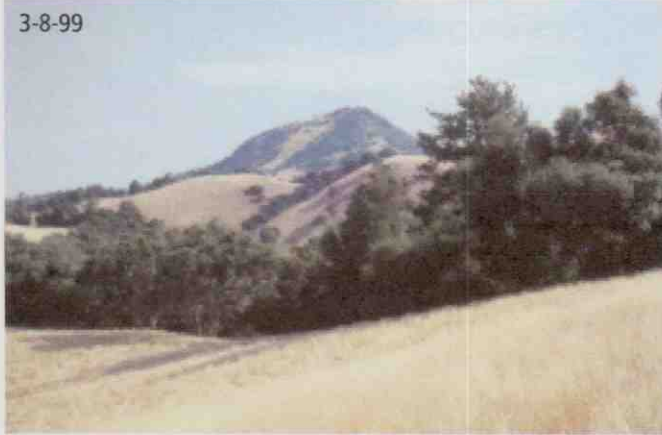
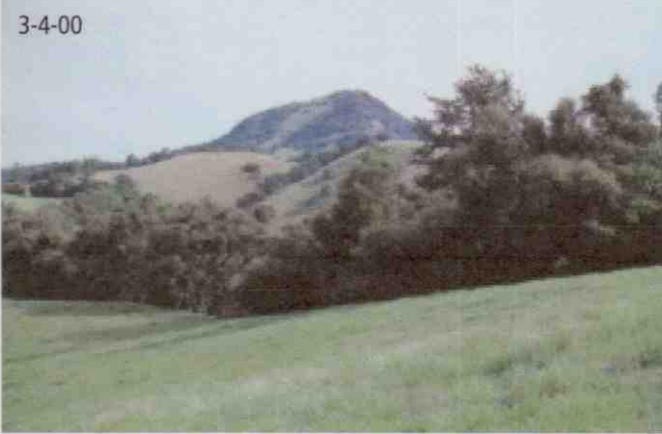
**Figure 1.** Annual landscape photos taken in early March (no photo is available for 1998).

*Landscape photos* should give a representative view of the area and feature a distinctive landmark in the background (e.g., a peak, rock outcrop, or ridgeline) to aid in taking follow-up photos in the future (Figure 1). Be sure to include enough horizon in the picture to allow a future photographer to find the same photo point again. You can record large areas of bare soil, erosion, weed and shrub invasions, and burns using landscape photos. *Plot or close-up photos* can be used to document ground cover, residual dry matter, erosion, endangered species, and weeds (Figure 2). *Riparian, stream, or wetland photos* provide a representative view of the stream channel, bank stability, ground cover, and overstory vegetation (Figure 3).

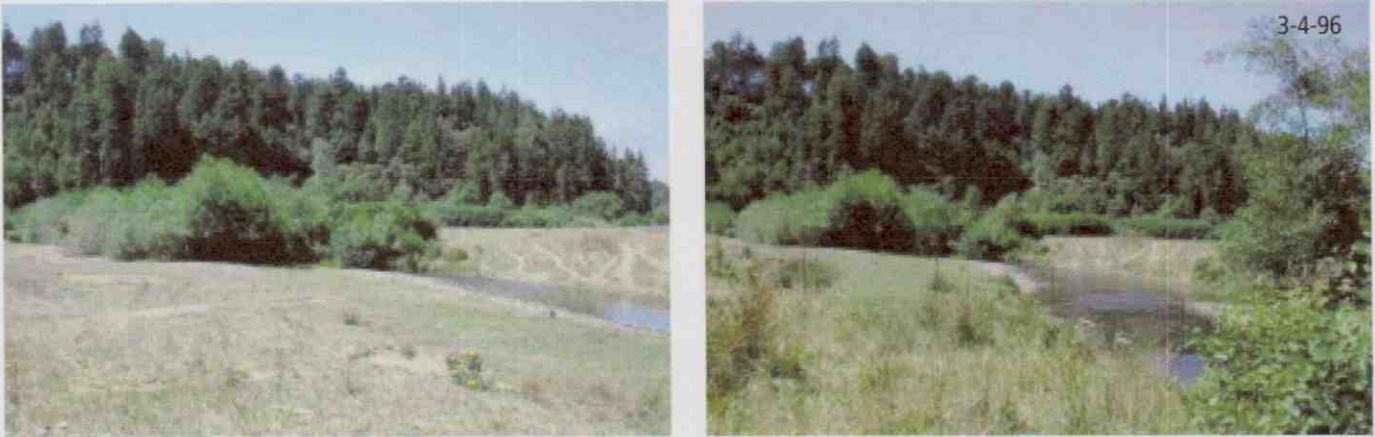
**Figure 3.** Riparian area photographed before and after installation of a fence.

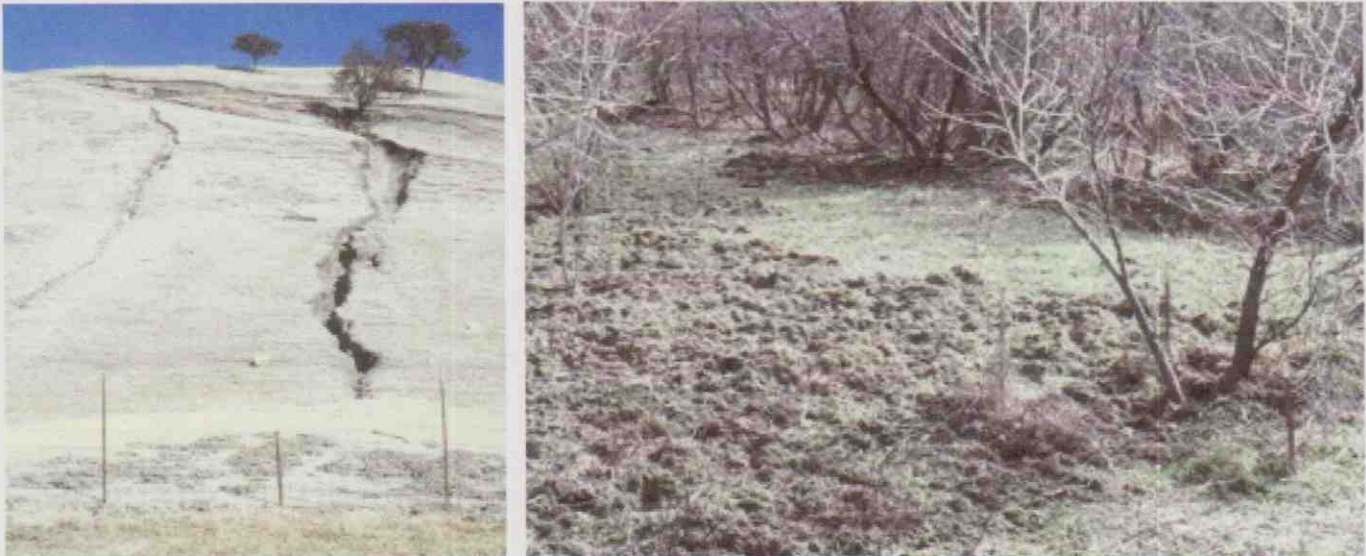
**Figure 4.** Photos taken to document events (gully formation and rooting by feral pigs).

*Event photos* can be used to document unplanned or unusual events such as fires, floods, erosion, wildlife damage, and vandalism (Figure 4), and *practice photos* can be used to document management practices (Figure 5). You can use “before and after” photos to document the implementation and effectiveness of practices, the effects of fire and post-fire recovery, the invasion and control of weeds and shrubs, and other long-term changes.

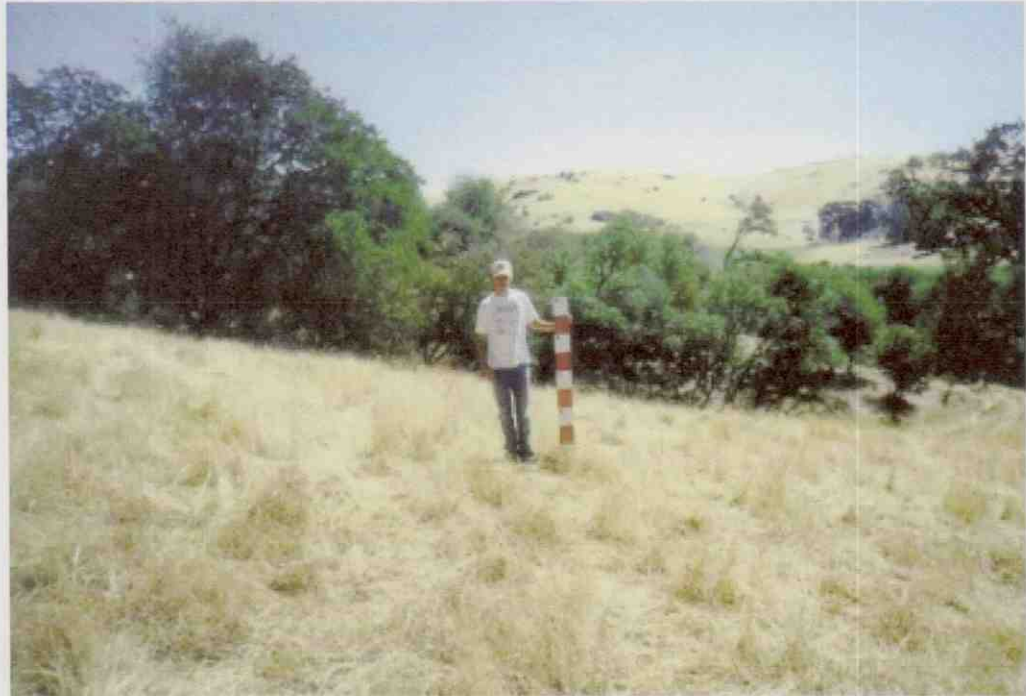
**Figure 7.** You can use a profile board to indicate scale in a photograph.
