# Sonoma County DRAFT Villa Grande Drainage Study September 2022

Job # SONO.01

PREPARED FOR: County of Sonoma 2300 County Center Dr Santa Rosa, CA 95403 Project #E20010

PREPARED BY: Schaaf & Wheeler 870 Market Street, Suite 1278 San Francisco, CA 94102

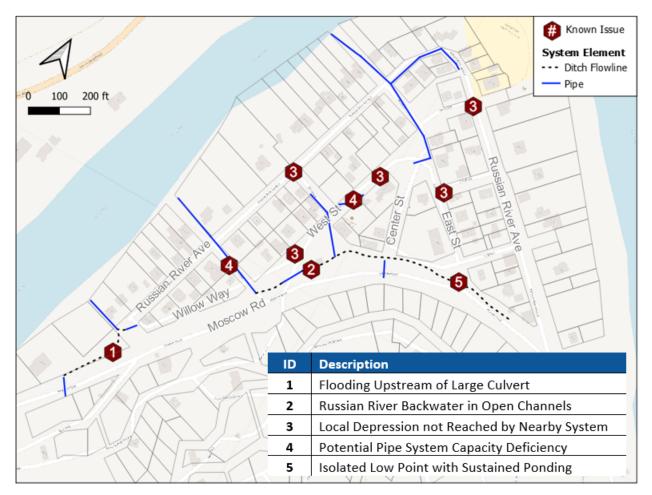
- Certain elements in the system don't appear to be functioning, whether due to blockages, failures, or simply undersized pipe. Specific locations include:
  - Pipes and inlets near the Post Office
  - Culvert(s) at the south end of Willow Way
  - The system along 6<sup>th</sup> Street that carries runoff from Willow Way to the River
  - Large area of ponding on the north side of Moscow Road, east of the bend in Center Street
- There are spots that tend to remain ponded after even small storms for extended periods of time
- There may be issues with backwater from the Russian River affecting the system. Backwater has been observed in the ditches parallel to Moscow Road.

Figure 5-1: Map of Drainage Issues Identified by the Community, County Staff, and Others.

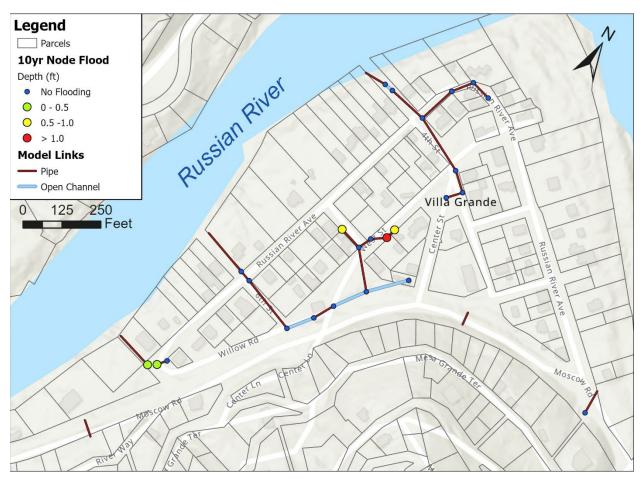
Figure 5-2: Existing System 10-year Node Flood Result from MIKE+

While the northern system appears to have no conveyance capacity issues in the 10-year event, the southern system lacks capacity in its upper reaches, near the post office on West Street and along 5<sup>th</sup> Street. The two culverts at the south end of Willow Way also appear to surcharge significantly

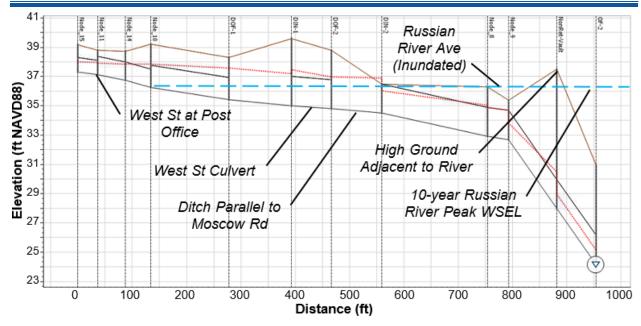
Based on topographic information available to us, it appears that high ground near the river would protect most of the community from a 10-year water surface in the River. However, the 6th Street system has inlets with ground surfaces at roughly 35.4 and 36.3. The culvert crossing West Street at the entrance to the community (which also drains to the 6<sup>th</sup> Street outfall) has a flow line at roughly elevation 35, allowing river water as far back as Moscow Road at a 10-year peak WSEL. A 10-year profile through the 6<sup>th</sup> Street system is shown in Figure 5-7.

Figure 5-7: System Profile from West Street to 6<sup>th</sup> Street Outfall.

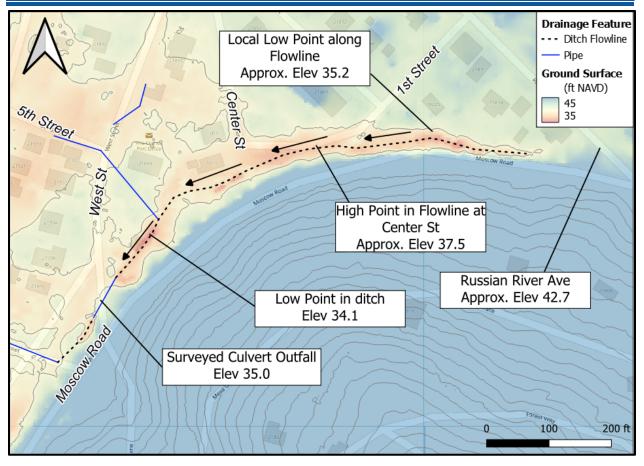
The community also identified an issue with drainage adjacent to Moscow Road near Center Street that is more difficult to evaluate with a model or calculation. This instead requires a more holistic approach to identifying the cause of the issue. Residents noted that after storms, sheet flow from Moscow Road enters the ditch to the north, adjacent to private properties, where it ponds and does not appear able to drain. The first step in evaluating this problem is examining the topography in the area. While survey isn't available across the entire community, 2017 Sonoma County LiDAR topography is available and can be used here. This is shown in Figure 5-8.

The model simply assumes all of the drainage that accumulates at this location makes it further downstream to the West St Culvert and 6<sup>th</sup> Street outfall. This is an important modeling assumption to ensure that the system downstream has adequate capacity to convey this drainage. Solutions to this issue are explored separately from other pipe system capacity improvements that would allow this impounded runoff to drain more freely.

Figure 5-8: Ditch Flowline Between 6<sup>th</sup> Street and Russian River Ave, Parallel to Moscow Road.

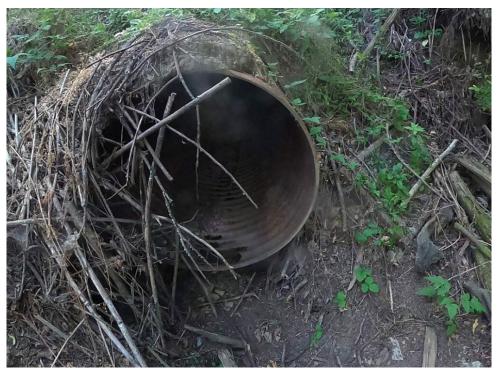
Outfalls to the Russian River are currently open pipe outfalls. The southern outfall is pictured in Figure 5-10.

Figure 5-10: Southern Pipe System Outfall (From 6<sup>th</sup> Street).

Tideflex valves are less expensive than check valves. However, as shown in Figure 5-10, these outfalls are susceptible to debris accumulation. If enough debris accumulates on either type of valve, they may not fully open during a storm to let water out of the pipe system. This may cause backwater into the system and result in flooding in Villa Grande. Mitigating for debris accumulation would require some form of debris rack, which would likely entail building a concrete structure at the end of the pipe.

There are a multitude of options for placing non-return type valves on these systems:

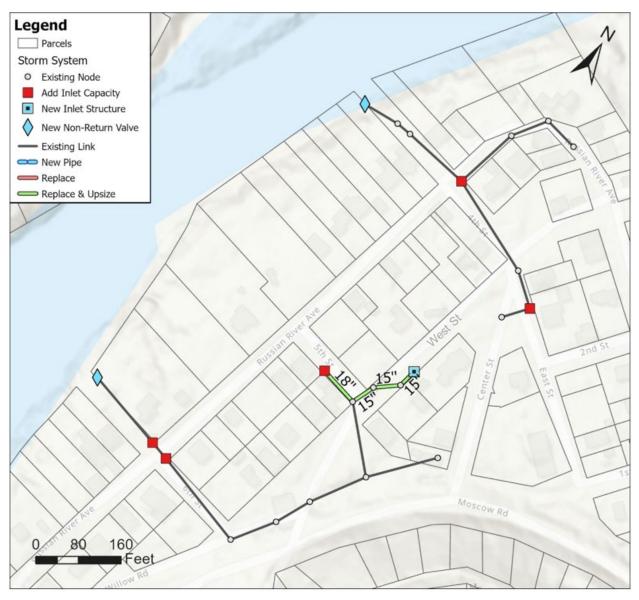
Figure 5-13: Villa Grande Pipe Conveyance Capital Improvement Alternative S-1 Map

Alternative S-1 would minimize the extent of pipe replacement and address the most urgent needs in the system. Improvements would be focused on eliminating flooding identified near the Post Office and on 5<sup>th</sup> Street. This would also add inlet capacity in the areas with the greatest need. The alternative is illustrated in Figure 5-13. Pipe capacity improvements are summarized in Table 5-6 (Non-return valves are shown in these figures, but are not part of the pipe system alternatives).

This alternative reduces flooding identified by the model along West Street and 5<sup>th</sup> Street by simply upsizing the existing system and adding inlet capacity where it's needed most based on the analysis of existing inlet capacity. In addition to pipe capacity improvements, this alternative

would add six grate inlets to the system to enhance the flow of runoff into the pipes and reduce nuisance flooding.

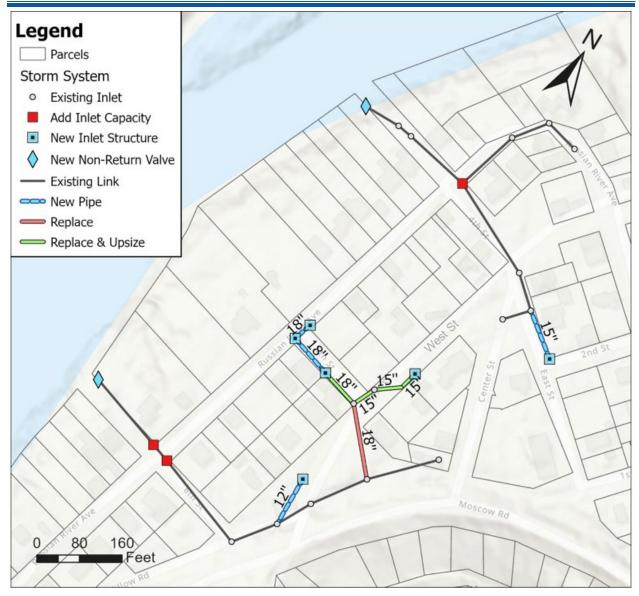
Figure 5-14: Villa Grande Pipe Conveyance Capital Improvement Alternative S-2 Map

In addition to pipe capacity improvements, this alternative would add up to 11 grate inlets to the system to enhance the flow of runoff into the pipes and reduce nuisance flooding.

This alternative is illustrated in Figure 5-14. Pipe capacity improvements are summarized in Table 5-7.

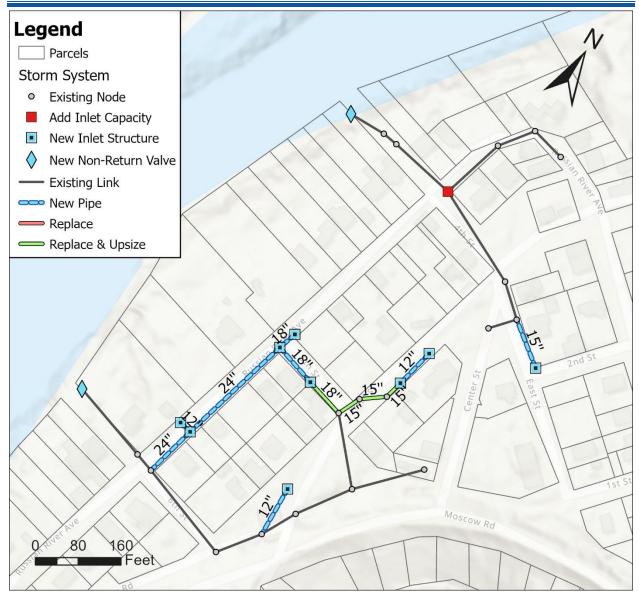
Figure 5-15: Villa Grande Pipe Conveyance Capital Improvement Alternative S-3 Map

In addition to pipe capacity improvements, this alternative would add 11 grate inlets to the system to enhance the flow of runoff into the pipes and reduce nuisance flooding.

This alternative is illustrated in Figure 5-15. Pipe capacity improvements are summarized in Table 5-8.

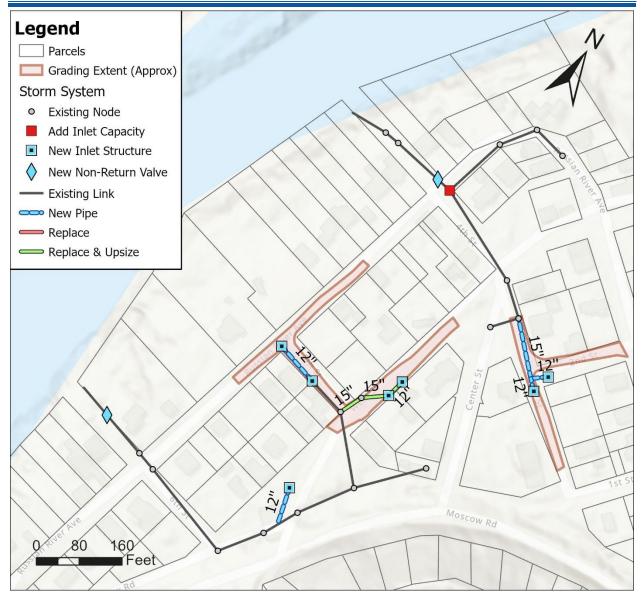
Figure 5-16: Villa Grande Pipe Conveyance Capital Improvement Alternative S-4 Map

An overview of this alternative is shown in Figure 5-16, with pipe system improvements summarized in Table 5-9.

This will still require the installation of 12 new 2'x3' (minimum) drain inlets distributed throughout the area to more efficiently capture drainage from the surface and reduce ponding depth and spread in roadways and properties during a storm. In certain areas where runoff concentrates heavily, inlets would be dual, side-by-side inlets to remove water from the surface more quickly.

This alternative also does not increase the size of certain existing pipes. The system extension shown in Alternative S-2 recommends 18" pipe on 5<sup>th</sup> Street. In order to install 18" pipe, however, replacement of the system downstream all the way to the ditch would be required. The preferred alternative instead balances system extension with utilizing existing capacity on 5<sup>th</sup> Street. Short duration system surcharge is generally tolerable and isn't likely to cause property damage. This project simply extends the 12" pipe to a new low point graded on 5<sup>th</sup> Street.

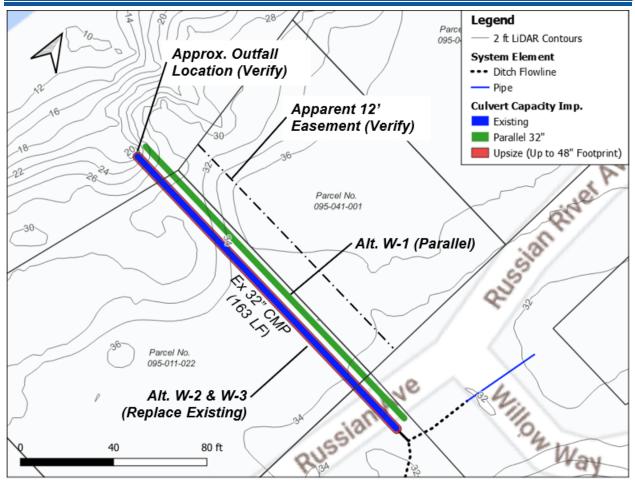
The approximate location of this culvert and conceptual footprints of improvement alternatives is shown in Figure 5-18. It's likely that before choosing an alternative to proceed with, more detailed topographic and boundary survey will be required. Access to the outfall of this culvert appears to be provided by a 12-foot easement, based on assessor maps (shown in Figure 5-19). However, upon superimposing the surveyed culvert inlet and the approximate location of the outfall on the GIS parcel data, it appears the existing culvert may not be located within the easement at all. This would place the existing pipe entirely on private property.

Figure 5-18: Willow Way Culvert Improvement Alternative Footprint Comparison.

The actual placement of a new or parallel pipe will most likely depend upon the actual size and location of existing easements. Without boundary survey, this is difficult to predict beyond superimposing GIS parcel data.

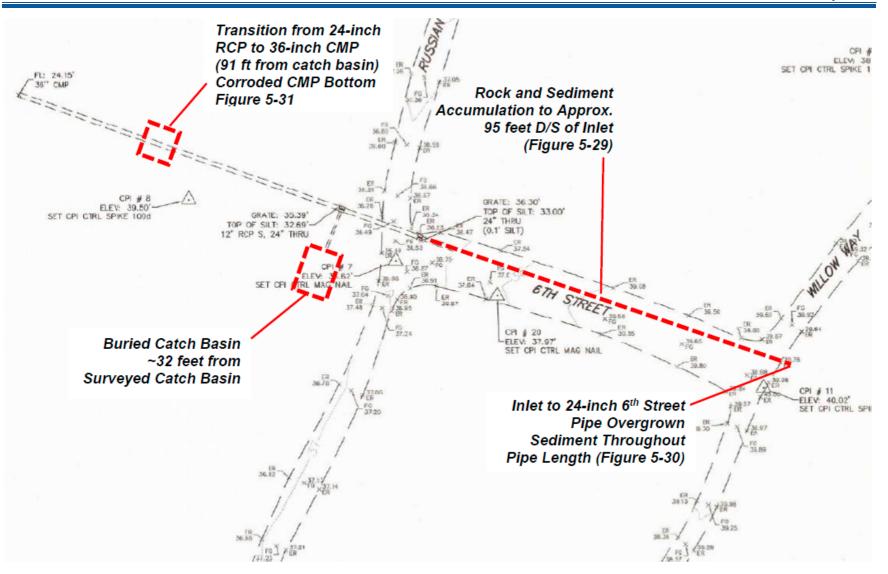
Figure 5-28: 6<sup>th</sup> Street System Condition

A plan view of identified issues in this system is shown in Figure 5-28. The inspection identified that some capacity has been lost to sediment deposition and overgrowth at the upstream end, along Willow Way. The pipe is in good condition at this location, but the system appears to need some maintenance to operate at full capacity. Further downstream, the missing catch basin was found approximately 32 feet to the south and is evidently buried under soil, vegetation, or debris. The pipe and structure seem to be in good condition but clearing is required to utilize the capacity of the system. Finally, the change in pipe material and diameter was located approximately 91 feet downstream of the most downstream catch basin. At this transition, the bottom of the CMP has completely corroded. It's very unlikely that this has any impact on capacity in its current state, as the CMP is a much larger pipe than the RCP upstream. However, if the pipe continues to corrode and fail more extensively, it may eventually cause a loss of capacity. This should be monitored occasionally if it's not replaced soon.
